Service Bulletin

Bulletin No.: PI1315

Subject: Sunroof Rattle in Full Open Position

Models: 2014 Chevrolet SS
Built Prior to January 9, 2014

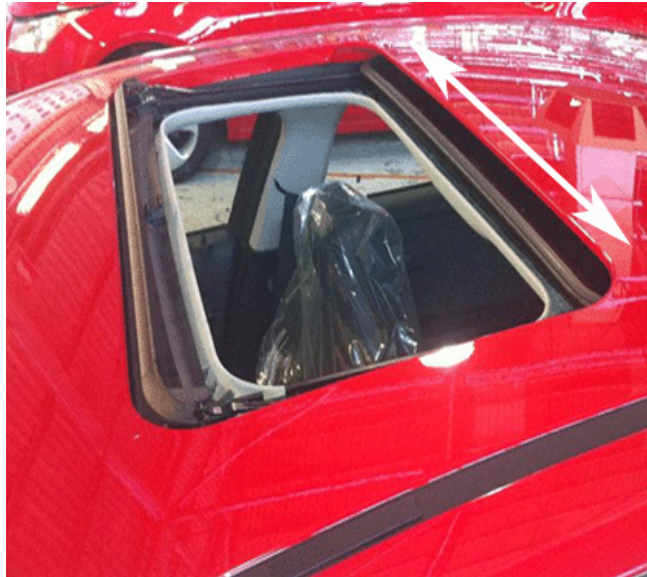
This may be caused by contact between the sunroof glass and the roof bow immediately rearward of the sunroof opening when the sunroof is in the fully open position.

1. Verify the sunroof glass flushness to the roof panel at the rear edge of the glass. The specification is glass over by 1 mm to glass under by 2 mm. Set the rear edge of the glass to 2 mm underflush to reduce the occurrence of the rattle.
2. Perform the static check.
