Service Bulletin

Bulletin No.: PI1319

Subject: Insufficient Air Flow from Second and Third Row Roof Vents

Models: 2012-2015 Chevrolet Express
2012-2015 GMC Savana

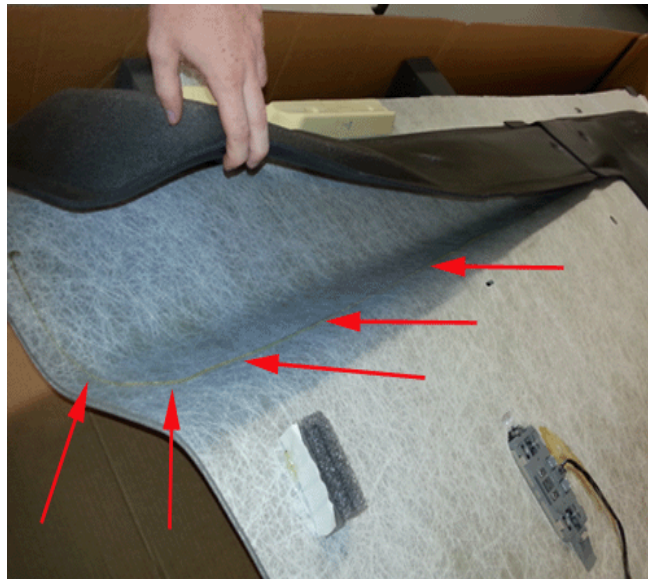
3975290

Some customers may comment about a lack of or no air flow from the second and third row roof vents. This may be due to the separation of the air cap from the headliner, causing air gaps.

2. Identify the locations of separation.
3. Apply a hot melt adhesive bead between the headliner and air cap where separation is found.
4. After applying the adhesive, apply a small amount of pressure to the flange areas of the air cap that have the new adhesive until the adhesive has cured enough to hold the air cap.
