Service Bulletin

Bulletin No.: PI1320

Subject: Airbag Readiness Light On, DTC B0031 0E and/or B0038 0E Set

Models: 2014-2015 Buick LaCrosse
Condition/Concern

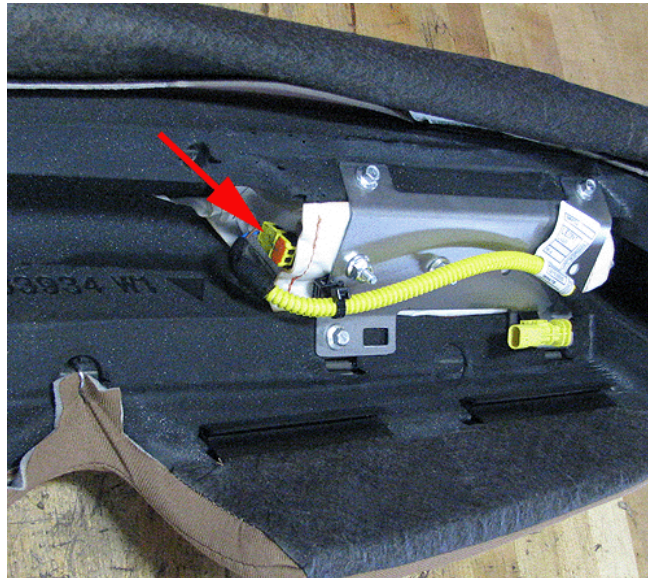
NOT OK — Visible Gap Between CPA and Connector

Check the appropriate rear side airbag connector based on the DTC set (see pictures below). If there is a visible gap between the orange CPA and the yellow connector, disconnect and reconnect the connector. Clear the DTCs and recheck.

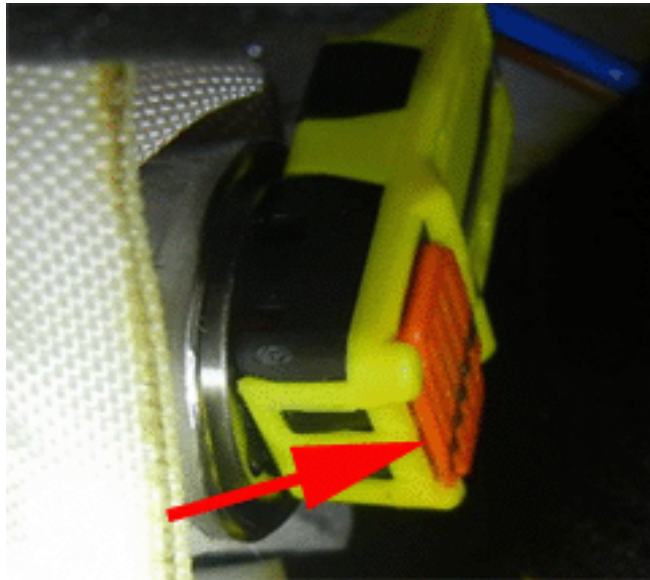
3979604

OK — No Visible Gap Between CPA and Connector
