# Service Bulletin

Bulletin No.: PI1343A

**Subject:** Harsh or Tie-Up Feeling from 6-4 Downshift

**Models:** 2012 Chevrolet Avalanche, Silverado, Suburban, Tahoe  
2012 GMC Sierra, Yukon Models  
Equipped with 6L80 Automatic Transmission (RPO MYC)

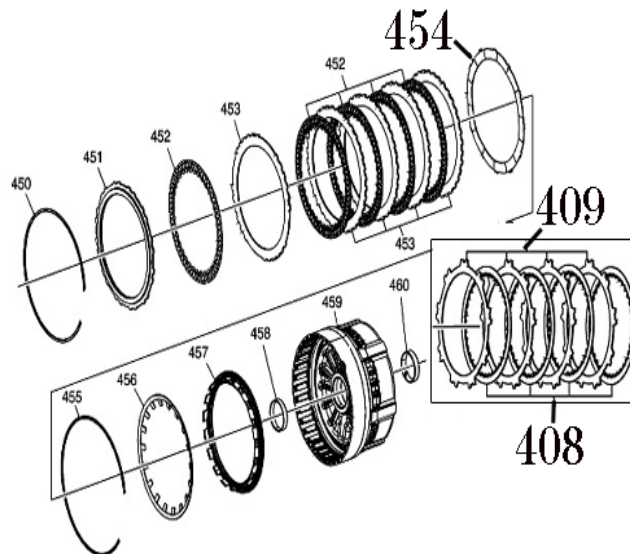
4004575

Some customers may comment on a harsh (detent) 6-4 downshift. The customer may also describe that during a heavy throttle application, a tie-up feeling followed after throttle has been released by a harsh 6-4 downshift.

1. Perform the Reset Transmission Adapts in Service Information (SI) (Document ID #2571000).
2. Road test the vehicle to verify if the condition has been corrected.
3. If the condition has been corrected, replace the 2-6 clutch wave plate (454).

**Note:** When replacing the 2-6 clutch waved plate, the 1-2-3-4 clutch fiber (408) and steel plates (409) should also be replaced as they are likely to be distressed.
