Service Bulletin

Bulletin No.: PI1377

Subject: Rubbing Noise in Steering Column when Turning Steering Wheel

Models: 2014 Cadillac ELR

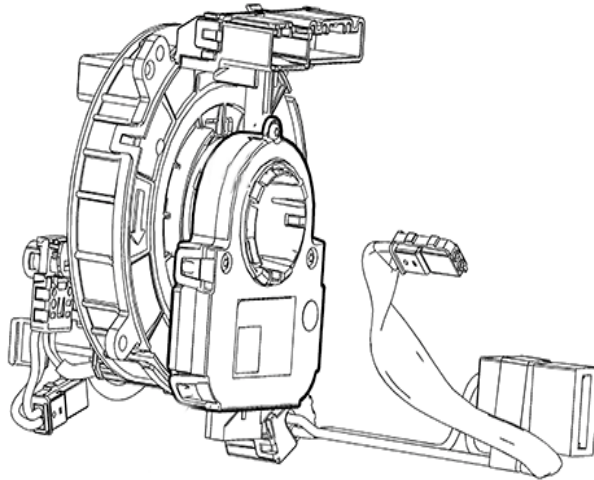
4035140

Some customers may comment on hearing a rubbing noise from the steering column while turning the steering wheel.

This may be caused by the steering angle sensor rubbing on the steering wheel airbag coil (SIR Coil).
