Service Bulletin

Bulletin No.: PI1378

Subject: Water Intrusion in Rear Compartment and/or Battery Compartment of Vehicle

Models: 2014-2015 Cadillac CTS Sedan (VIN A)
Built Prior to September 9, 2014

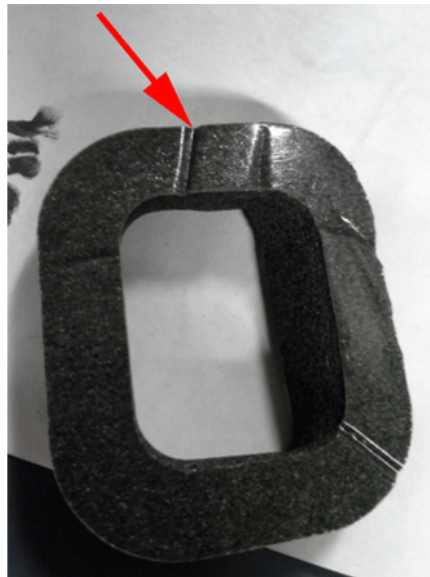
4038892

During installation, the foam seal around the taillamp electrical connector and/or guide pin may have been creased, allowing a path for water intrusion.
