Service Bulletin

Bulletin No.: PI1380

Subject: No GPS Signal Displayed or Navigation System Does Not Recognize Location of Vehicle

Models: 2015 Chevrolet Corvette
Equipped with Vehicle Performance Data System (RPO UQT)

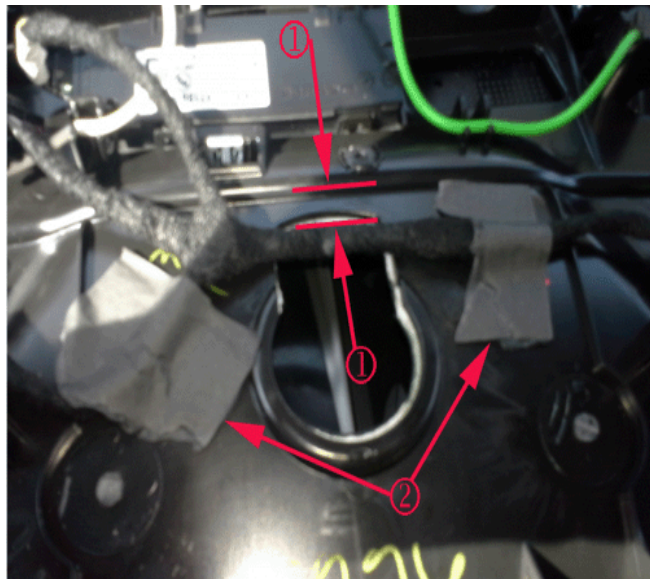
3998189

This may be due to the frontview camera coax cable being pinched by the courtesy lamp harness from the windshield upper garnish molding.

5. Reposition the courtesy lamp harness 13 mm (1) (0.50 in) as indicated in the illustration above.
6. Cut approximately 101 mm (4 in) from a roll of Nashua 357 Duct Tape or equivalent and secure the courtesy lamp harness down (2) as indicated in the illustration above.
7. Re-install the upper garnish molding. Refer to the Windshield Upper Garnish Molding Replacement in SI.
8. Clear all diagnostic trouble codes (DTC).
