TECHNICAL BULLETIN
Q336 UPS5513-5bNAS1
11 APR 2014

SECTION: 417-02

Update Prior to Sale: Door Interior Release Handle Lamp Operation

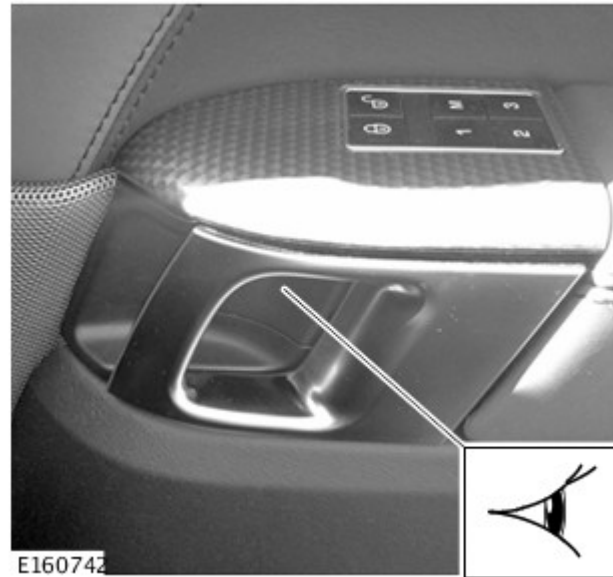
1. Turn the side lights 'ON'.
2. Check that the small white lamp at the front right door interior release handle aperture is

illuminated.
