TECHNICAL BULLETIN
Q336 UPS5513-6bNAS1
17 SEP 2014

SECTION: 417-02

Update Prior to Sale: Door Interior Release Handle Lamp Operation

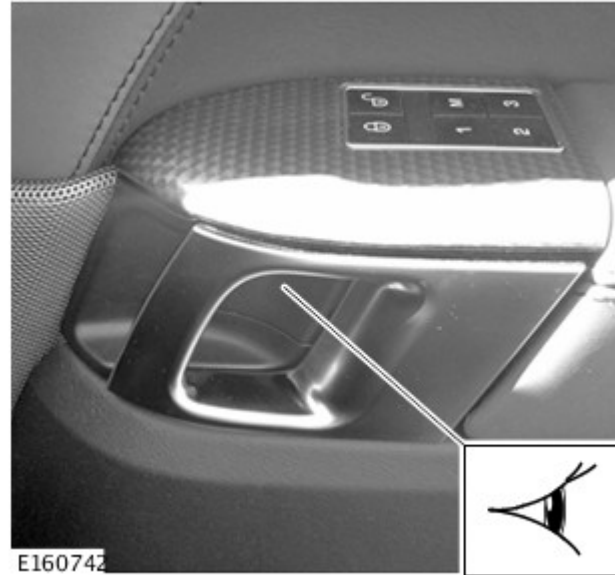
2. Check that the small white lamp at the front right door interior release handle aperture is

illuminated.

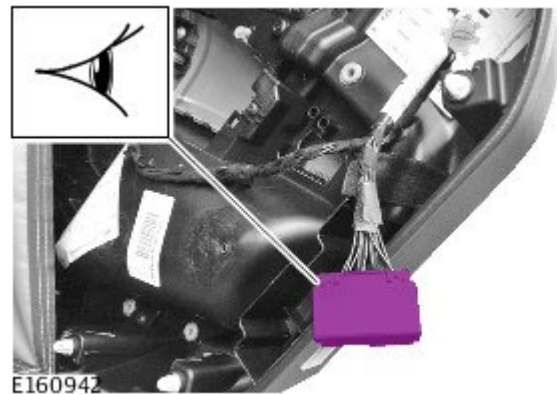
4. Modify only the harness shown in steps 5-8 that comes from the door casing harness, **not** the body harness.

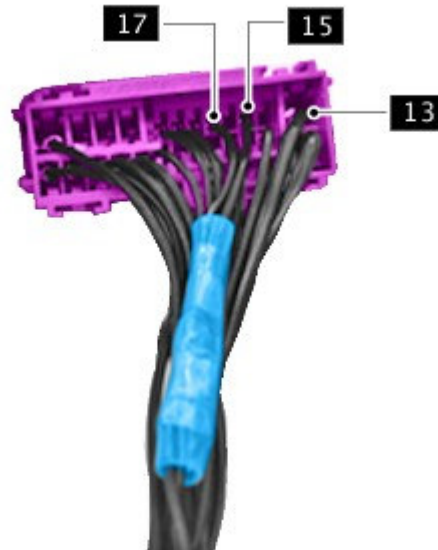
5.

Situation: A limited number of vehicles within the listed VIN ranges may not have the required power feed to the lamp above the door interior release handles located in each door casing.

Modify door casing harness:

- If required, remove the front right door trim panel for access only (see TOPIX Workshop Manual, Section 501-05).
- Disconnect electrical connector (C3B-C2).

- Locate wires in pins 15 and 17; cut each wire 50mm back from the connector. Strip wires 15 and 17 on the connector side and twist the exposed copper together. Place the splice into the splicing tool, put the wires into the splice, and then crimp all together.

- Strip wires 15 and 17 on the door trim harness side and twist the exposed copper together. Place the wires into the splice which has already been crimped on the other side. Crimp the door trim harness side.

- Wrap the splice in two turns of fleece tape to secure.
- Connect electrical connector (C3B-C2).
- Turn side lights 'ON' and check that the white LED is now working.

- Turn side lights 'OFF'.
- Install front right door trim panel (see TOPIX Workshop Manual, Section 501-05).
