TECHNICAL BULLETIN Q431 UPS8514-1bNAS1 17 NOV 2014

SECTION: 310-02

Update Prior to Sale: Accelerator Pedal Defective Switch

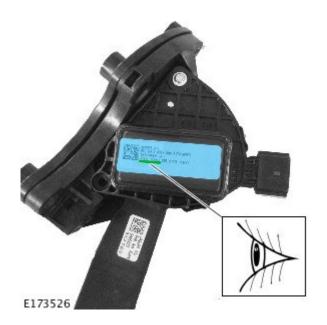
1. ONOTE: if you are unable to view the serial number on the accelerator pedal, remove the accelerator pedal (see TOPIx Workshop Manual, section 310-02).

Check the accelerator pedal serial number.

- If the accelerator pedal serial number is not listed in the table above, reverse the removal procedure and release the vehicle.
- If the accelerator pedal serial number is in the table above, hold the vehicle for further parts ordering information.
