Service Bulletin

Bulletin No.: PIC5398C

Subject: Mist From Instrument Panel Vents, Moisture On Windshield Or Water On Floor

Models: 2010 - 2014 Buick LaCrosse
2011 - 2014 Buick Regal
2013 - 2014 Chevrolet Malibu

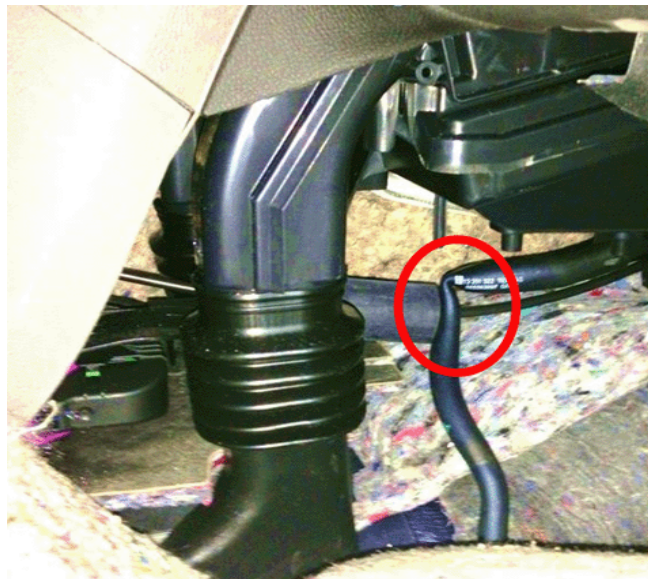
3533185

Reposition the passenger side front carpet to inspect the evaporator case drain hose, the hose is likely caught on the foam isolator on the transmission shift cable. Reposition the shift cable to the driver's side of the vehicle and push slack of the cable and the insulator forward into engine compartment. See photo's attached for reference.
