# Service Bulletin

Bulletin No.: PIC5520K

Date: April, 2014

**Subject:** BAS+ (HYBRID) eAssist Drive Motor Generator Battery Module (Powerpack) or Drive Motor Generator Battery Section Exchange Process And Order Instructions

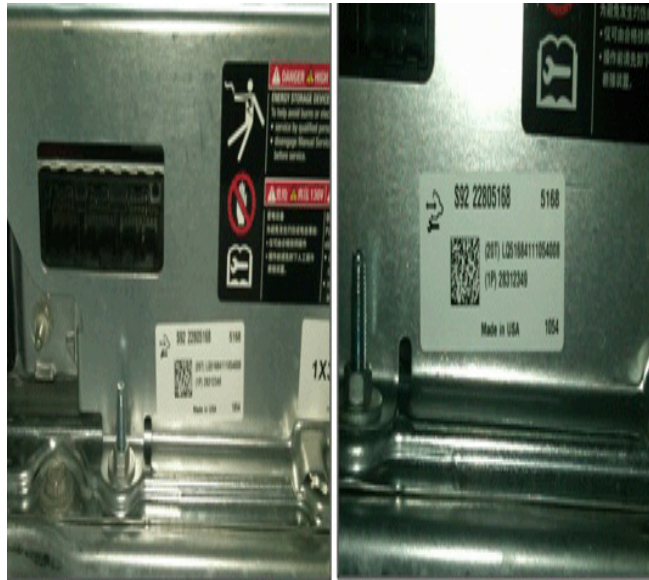
2688041

- The parts department fax number
  - The Powerpack serial number (Battery Identification Number)
9. The Battery Identification Number (BIN) tag is located on the side of the assembly cover. Locate the tag and record the 16 digit Battery Identification Number. The BIN number begins with digits "20T" (See Photo Below). If the Generator Control and Battery Module is not out of the vehicle yet, you can find the assembly ID number by installing the MDI and using GDS2. Access the Battery Energy Control Module menu and look under the ID Information section for the sixteen digit number. It will be listed under the parameter: Hybrid Battery Pack Identification Number. You will need to record the serial number and supply it to TAC when requesting a Powerpack or Battery Sections.
