Service Bulletin

Bulletin No.: PIC5884B

Subject: Trunk Lid Does Not Self Raise Completely

Models: 2014 Chevrolet Impala

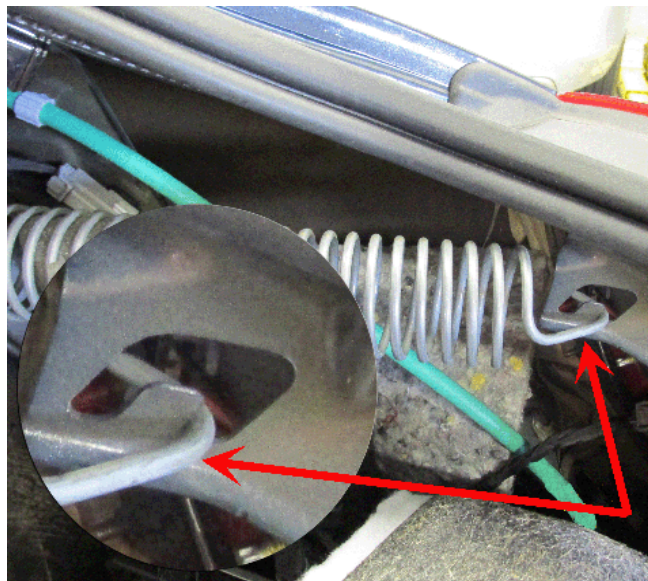
3530798

It may be noticed that the Trunk lid does not self-raise to the full upright position when released. This applies only to vehicles with Factory Installed Rear Spoilers or Dealer Installed GM Accessory Rear Spoilers prior to January 1, 2014.

Assure that both trunk lift springs are in the rear-most position, as shown below. Refer to Service Information for the Rear Compartment Lid Hinge Spring Replacement.
