# Service Bulletin

Bulletin No.: PIC5895C

**Subject:** Blower Motor Fan Speed Frozen on Display

**Models:** 2013 Chevrolet Camaro  
Equipped with Either Radio RPO UFU or UHQ

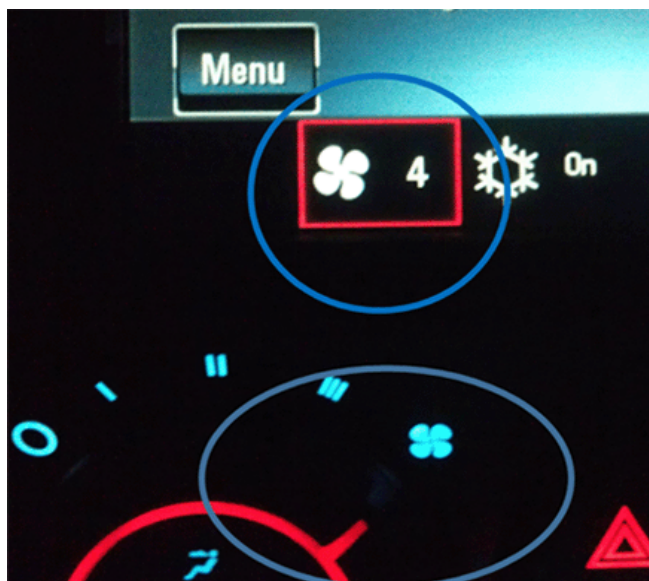
4001827

Some customers may comment that the blower motor fan speed display is "frozen" on the radio display. This will be noticed after the vehicle has been started. For example, in the photograph below, notice that the blower motor rotary knob has been set to the "high" position but the indicated blower motor speed above it shows blower speed as level 4. This is shown as an example only. The actual car may freeze on any indicated blower motor speed.

The cause of this specific concern is due to a software mismatch between the Electronic Climate Control Module (ECC) and the radio.

If the customer's vehicle exhibits the concern described above, dealership technicians are to contact the General Motors Technical Assistance Center (TAC) to request the software fix for this issue.

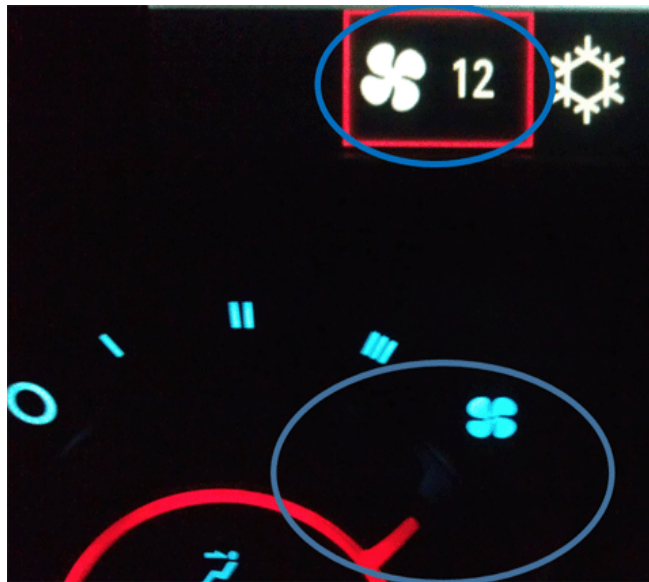
4001832

The following photo shows a correctly operating HVAC system. The blower motor rotary knob has been set to the "high" position once again, but the radio display correctly indicates the blower speed as level 12.
