# Service Bulletin

Bulletin No.: PIC5955

**Subject:** 4ET50 Electric Drive Unit Service – Rotor B Replacement

**Models:** 2011-2014 Chevrolet Volt  
2014 Cadillac ELR

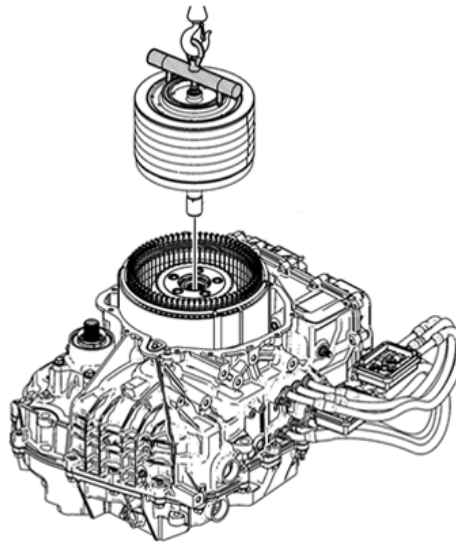
3696546

When replacing the Rotor B Assembly, it is imperative that the technician follows SI (Document ID: 3641026) exactly step by step. The transmission must be removed from the vehicle. Attempts to try this as an on-car procedure will result in subsequent failures and possible transmission damage. Damage or repeat repairs due to not following publish procedures will not be covered by warranty.
