Service Bulletin

Bulletin No.: PIC5964A

Subject: Diagnostic Tip - Clarification Of Vehicles Equipped With Fog Light (RPO T3U)

Models: 2014 - 2015 Buick Lacrosse

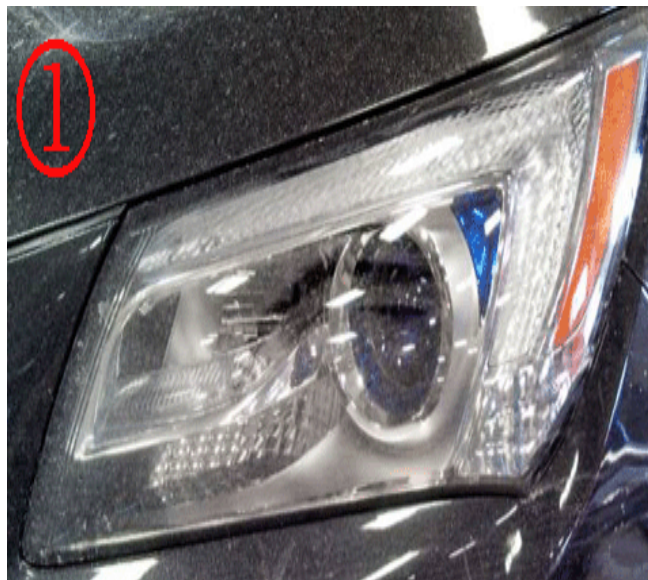
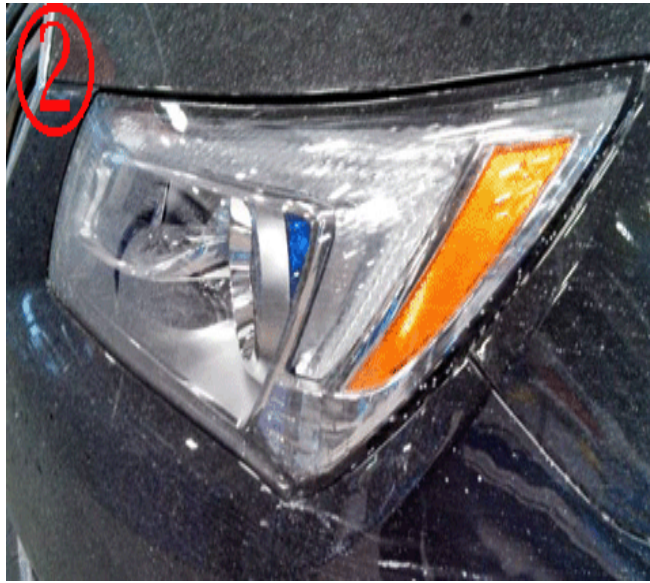
BASE equipped RPO T4A (HEADLAMPS-HALOGEN) without (RPO T3U) Images 1 and 2.

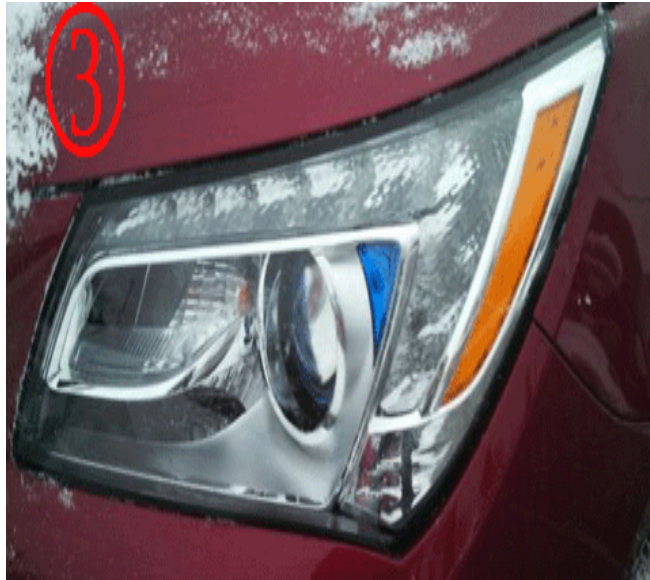
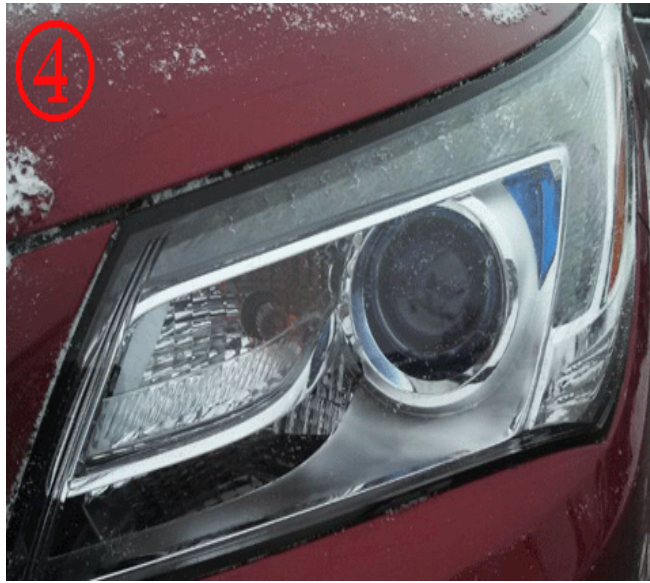
UPLEVEL equipped RPO T4F (HEADLAMPS-HIGH INTENSITY DISCHARGE) Images 3 and 4.

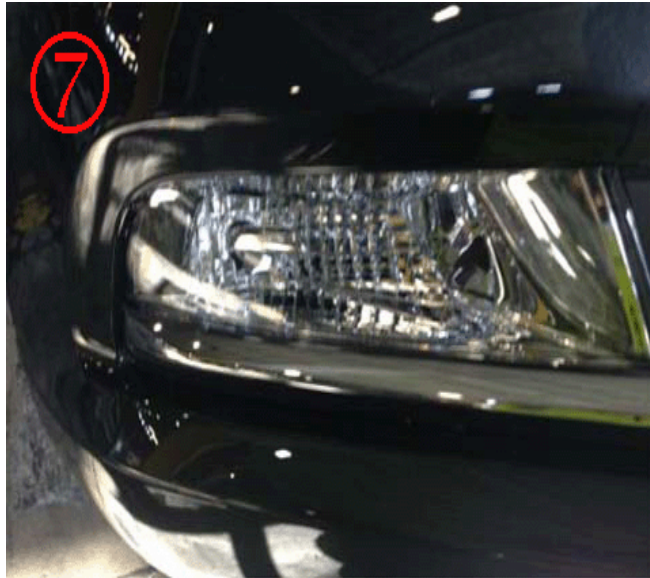
3721305

Daytime Running Light (base)

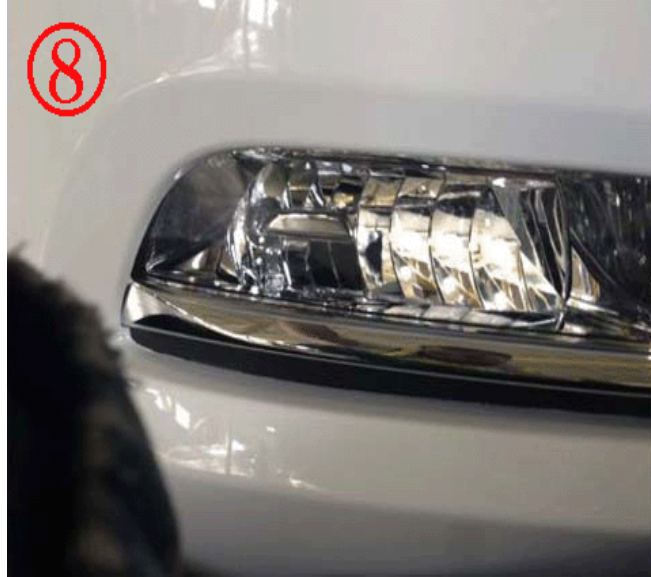
3721310

Fog Lamp (uplevel)

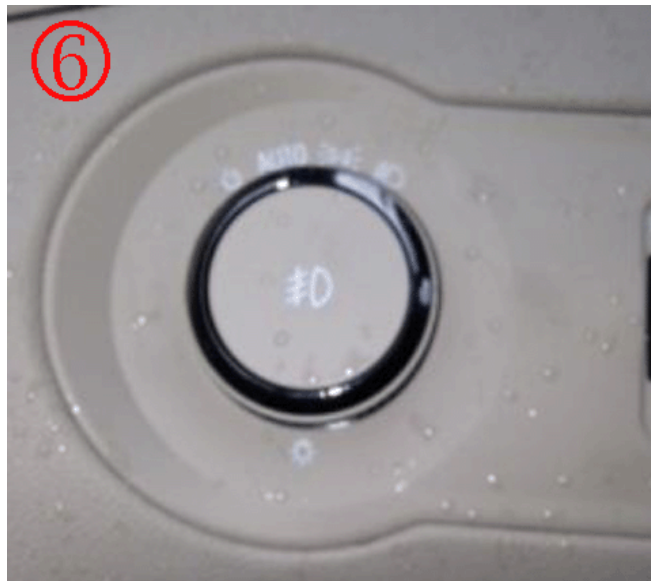
3721297

Fog Lamp Switch RPO T4F (HEADLAMPS-HIGH INTENSITY DISCHARGE and RPO T3U) is in the center of headlight switch.

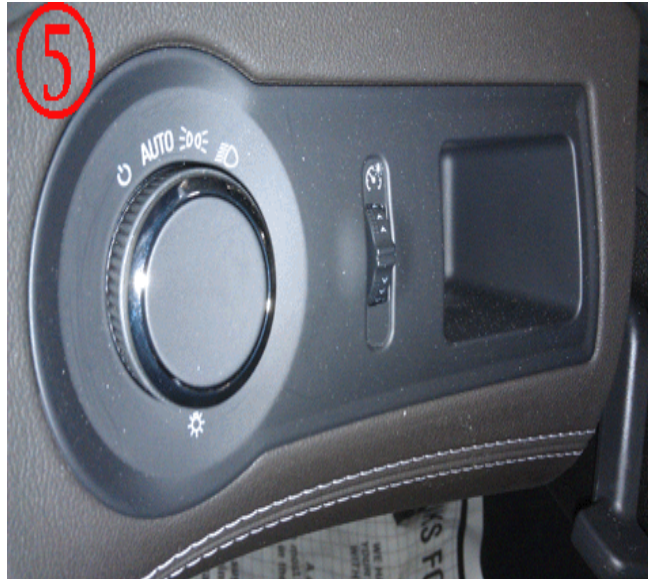
3721292

No Fog Lamp switch RPO T4A (HEADLAMPS-HALOGEN)
