Service Bulletin

Bulletin No.: PIC5973

Subject: Diagnostic Tip - Rear Toe Adjust Link Dampener Service Guidelines

Models: 2010 - 2014 Buick Lacrosse (built prior to 02/19/14)
equipped with 4 Link Rear Suspension (RPO GNC)

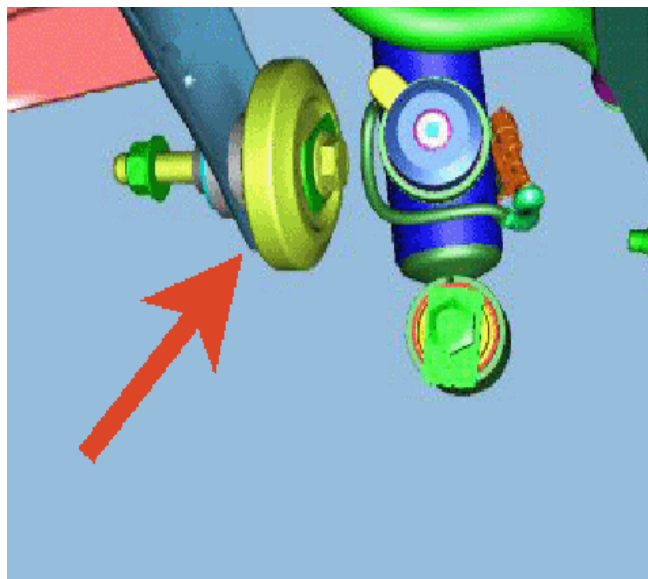
Vehicles listed in the Models section above were built with a dampener on the rear toe adjust link - as reflected in the first image below.

The two photos below show the link with and without the yellow dampener. The second image below shows the shorter bolt without the dampener and washer.
