# Service Bulletin

Bulletin No.: PIC6001

**Subject:** Wind Noise From Front Of Vehicle While Driving

**Models:** 2014 Chevrolet Camaro  
Equipped with the RS Package (RPO WRS)

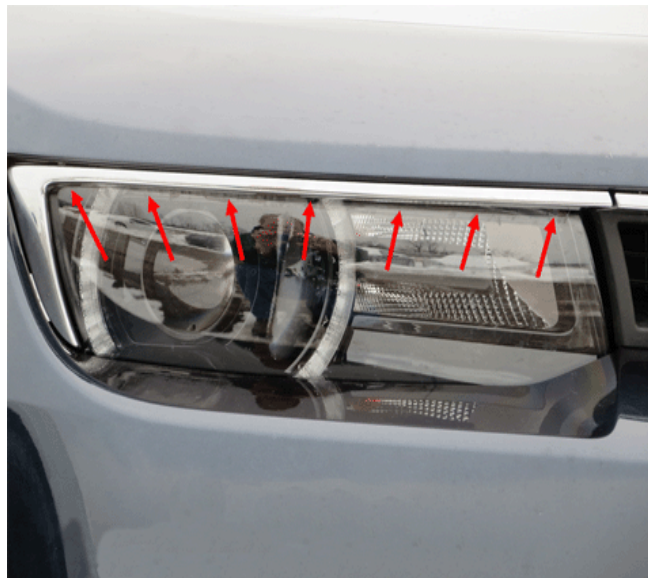
3806374

Through extensive testing on this issue, it has been confirmed that this whistle noise may be caused by wind rushing over the various gaps around the headlamp capsules of the vehicle. This issue may produce a higher pitched wind noise when the car is driven at speeds of 40 MPH and greater. It may even be difficult for every technician to hear this noise. Depending on the direction and severity of the wind, as well as the direction and pitch of the vehicle, this noise may come and go completely, or this may simply change in volume. To narrow this concern down, dealership technicians are to apply 2" wide masking tape along the upper edge of both headlamp assemblies, make sure that the tape covers the gap between the headlamp capsules and the adjacent chrome trim directly above it. Test drive the vehicle to confirm that the noise has been eliminated. It has been found that either headlamp may contribute to this noise.

Area of Concern: Most cases have been found to be caused by the gap between the headlamp capsule and the chrome trim around the top edge of the headlamp capsules. This gap has been pointed out using the red arrows in the photo below.

With the aid of an assistant, have them lift up slightly on the chrome trim above each headlamp assembly. Dealership technicians are to run a bead of silicone between the headlamp capsule and the chrome trim above it. Then, have the assistant release the chrome trim so it relaxes itself into the wet bead of silicone. After this has
