# Service Bulletin

Bulletin No.: PIC6006

**Subject:** Rattle Noise From the Exhaust

**Models:** 2010 - 2014 Chevrolet Camaro

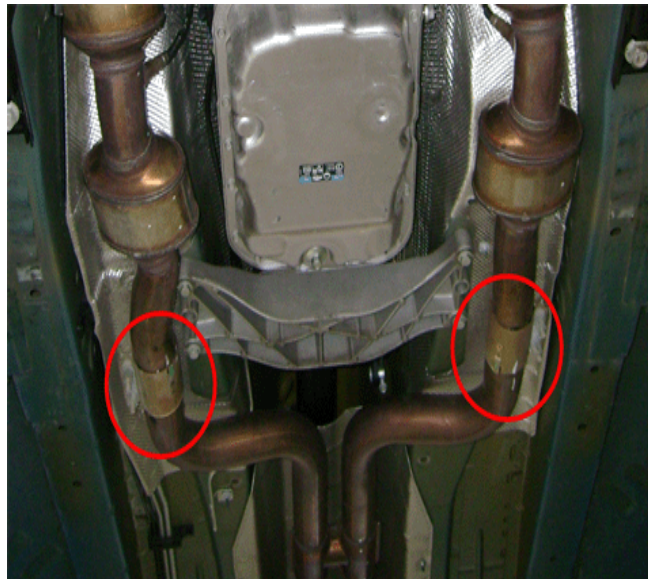
3829007

Customers may comment on a rattle noise coming from their vehicle. Upon inspection, dealership technicians may have difficulty in determining where the source of this noise may be coming from. It may even sound like it originates from the transmission area, when in fact, it may be coming from the exhaust system. If a noise concern is being addressed from underneath the vehicle, dealership technicians are to first strike the exhaust system with a rubber mallet or a deadblow hammer and listen for the noise to occur. If a noise is heard, inspect the area of the exhaust where the two front exhaust band clamps join the front catalytic converter assembly to the rest of the exhaust system. See the photo below for the area of these clamps. These clamps have been circled for each bank.

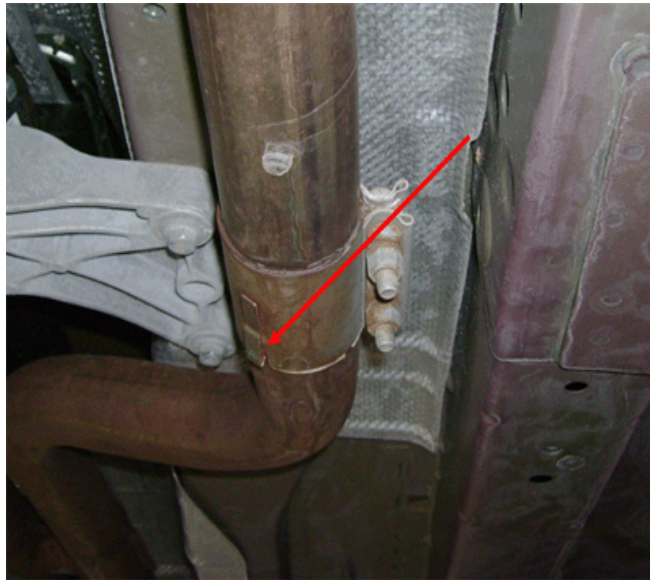
3829013

This joint is called a Torca coupling. In this coupling, a small alignment tab is welded onto the exhaust pipe. Then, a band clamp is positioned around the joint and slid towards the rear of the vehicle until a notch in the band clamp slides around this alignment tab. This assures that the clamp is properly positioned on the exhaust before it is tightened down. As this clamp is slid into position, another "J-shaped" piece of metal, referred to as a clip, slides up and over this alignment tab to "lock" this clamp into position on the pipe. The photo below shows what a normal coupling looks like. The red arrow points to the clip that hooks over the top of this alignment tab.

In certain instances, a rattle noise may be heard coming from this coupling and there are 2 likely possibilities for this noise concern.

Concern 1) This J-shaped clip may rattle against the exhaust pipe causing the noise

Concern 2) The alignment tab that was originally welded on the exhaust pipe may have separated from the exhaust pipe and is now causing a rattle noise.

If a noise has been confirmed from this coupling, carefully inspect this area of the exhaust for any obvious damage or looseness in the related components. If nothing is found, bend the J-shaped clip away from the exhaust pipe. If the small alignment tab is found to be loose, completely remove it from the exhaust pipe. In most cases this can be accomplished with the use of a regular screwdriver. Make sure the J-shaped clip will no longer contact anything which may cause another rattle noise in the future.

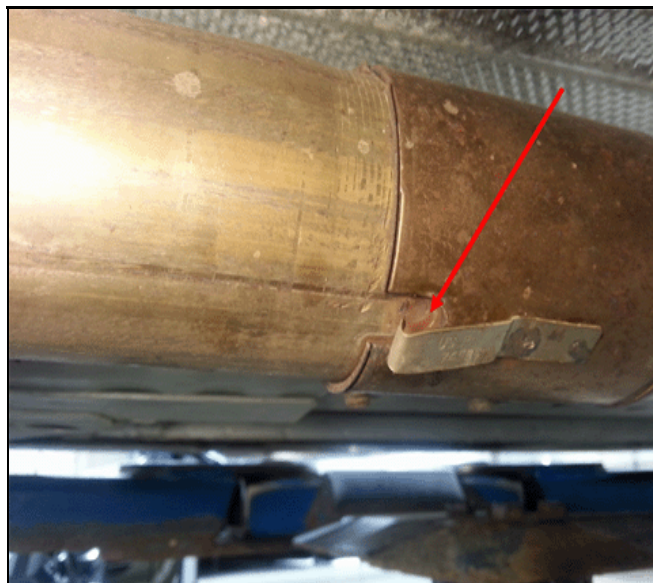
3829003

See the photo below for an example of a repaired coupling.
