Service Bulletin

Bulletin No.: PIC6026

Subject: Unable To Connect High Voltage Cable To Replacement Accessory DC Power Control Module (APM)

Models: 2011-2013 Chevrolet Volt

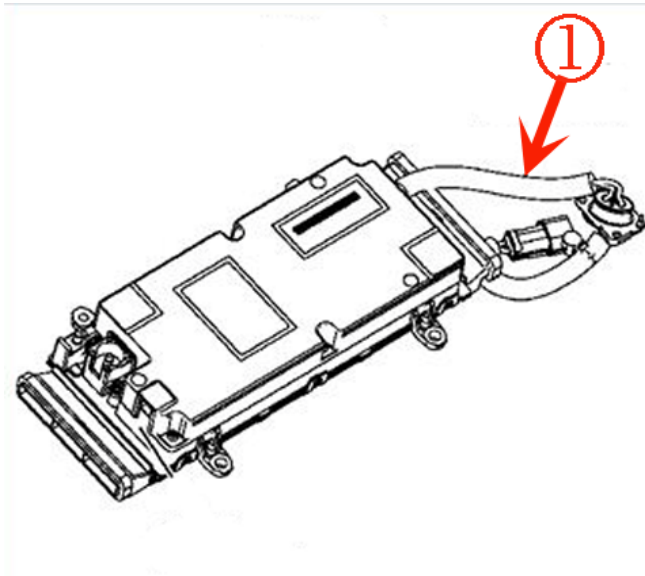
3256768

Certain 2011-2013 Chevrolet Volts were equipped with a first design APM which has a 24 inch orange pigtail attached to the module and there is no high voltage connection right at the module itself (See Photo Below)

If your vehicle has a first design module and you are replacing the APM , an additional jumper harness (GM Part Number 24268507) will need to be installed. An instruction sheet will be provided with the jumper harness kit on how to install the new design module. If the jumper harness instructions were not included with the new part, please contact the Technical Assistance Center for a copy of the instruction sheet.
