Service Bulletin

Bulletin No.: PIC6051

Subject: Unwanted Window Reversal During An Express Up Function

Models: 2015 Cadillac ATS Coupe

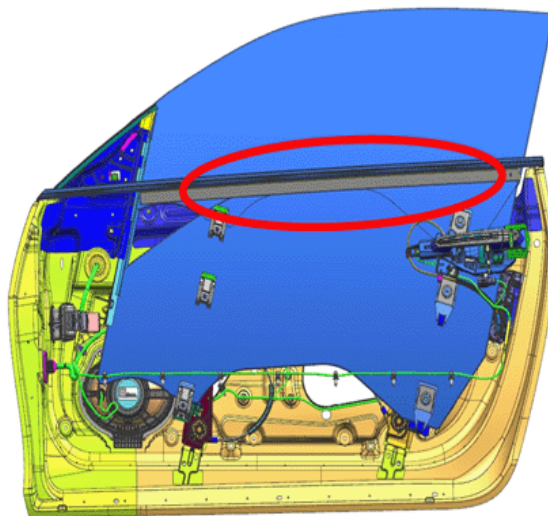
4006237

1. Check the inner belt molding to make sure it was not installed too far forward causing the lip to fold over adding resistance to the window operation.

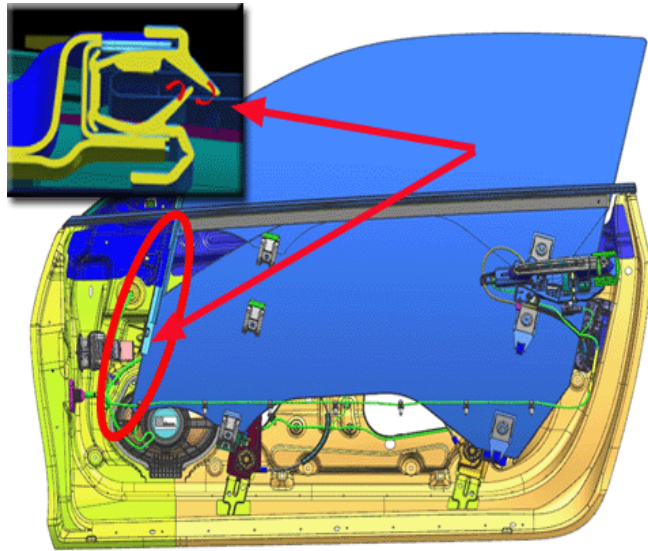
4006234

2. Check the forward run channel seals to make sure they are not folded under the forward edge of glass. You cannot see this unless you look down through the belt line seals
