Service Bulletin

Bulletin No.: PIE0301

Subject: Engineering Information – Side Object Blind Zone Indicator Stays On at All Times

Models: 2014 Cadillac CTS Sedan (VIN A) with one or more of the following RPOs: UFT, UD7, UFG

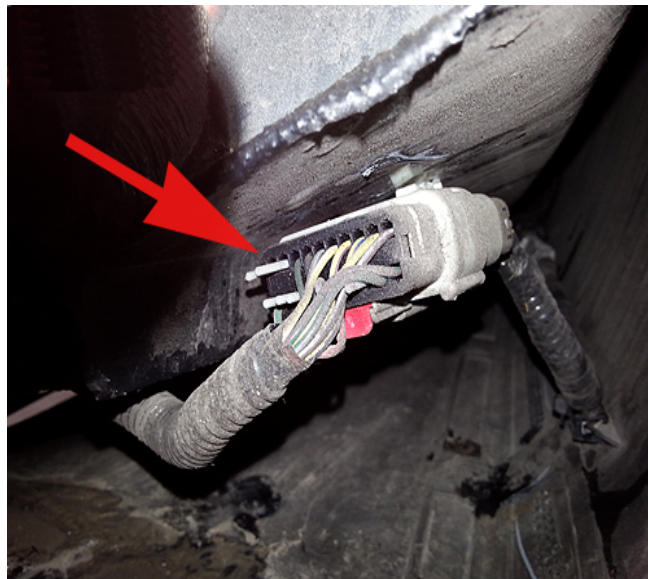
Some customers may comment that the side object blind zone indicator stays on at all times, even when the vehicle is shut off. This condition may occur on one or both sides.

1. Remove left hand rear wheel and wheel liner. Refer to Rear Wheelhouse Liner Replacement in SI. It is not necessary to remove the complete liner, only loosen the rear section for inspection.

2. Take picture of connector X415 in the as received condition.
3. Examine connector X415 for signs of water intrusion while still connected.
4. Disconnect X415 and examine for water intrusion and take pictures of open connector.
