Program Bulletin

CUSTOMER SATISFACTION PROGRAM

SUBJECT: Manual Transmission Stuck in Gear

MODELS: 2014 Chevrolet Camaro
Equipped with Manual Transmission (MG9, M10, MM6)

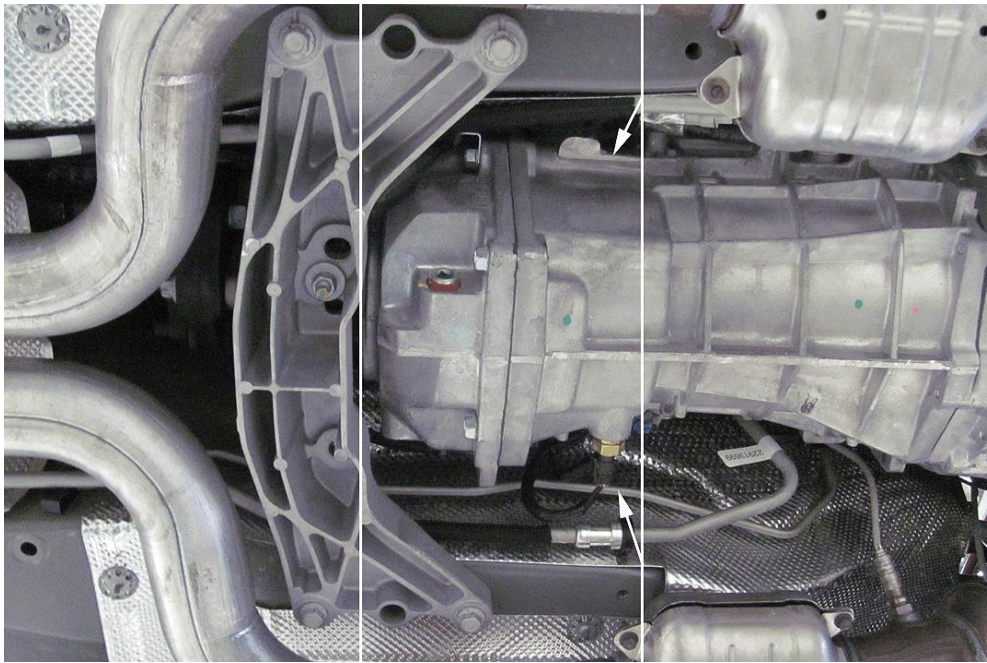
Note: A borescope is required to inspect for the presence of the shift linkage retaining clips and pin. Inspect both the left and right side of the shift linkage assembly. A complete inspection includes verifying the presence of one pin and two retainers. The shift linkage retaining clips and pin are located on the top side of the transmission. Refer to the borescope inspection zone in the photograph. The arrows in the photograph indicate where to insert the bore scope. The two lines in the photograph represent the inspection zone.

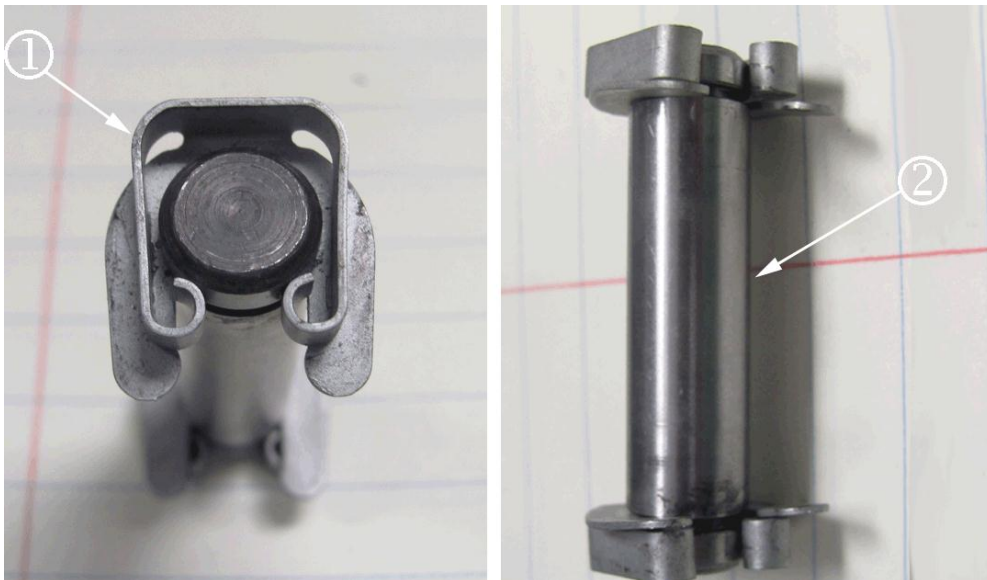
4. Visually inspect for one retaining clip on each side of the shift linkage pin.
 - 4.1 Route the borescope along the transmission tunnel heatshield roof and down toward the transmission to locate the shift linkage pin and retaining clip on the driver side of linkage.
 - 4.2 Route the borescope along the transmission tunnel heatshield roof and down toward the transmission to locate the shift linkage pin and retaining clip on the passenger side of linkage.

- If the retaining clips (1) and shift linkage pin (2) are present, no further action is required. Lower the vehicle. Refer to *Lifting and Jacking the Vehicle* in SI.

- If the retaining clips (1) or shift linkage pin (2) are NOT present, proceed to step 5.
5. Remove transmission from the vehicle. Refer to *Transmission Replacement* in SI.

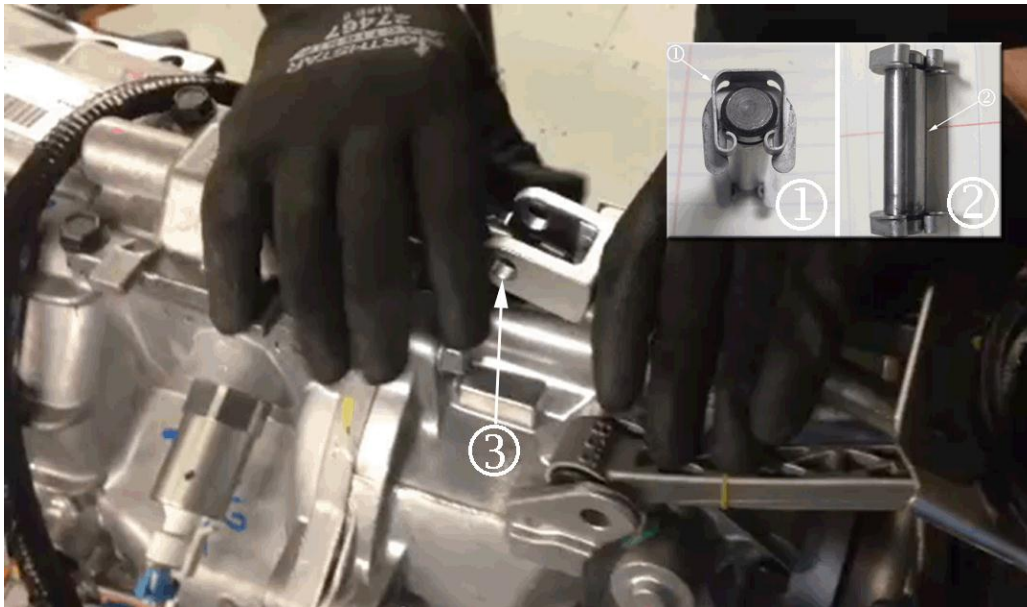
Top side of the manual transmission shown on a work bench. The yoke connecting the shift mechanism to the transmission is installed with a linkage pin and two retaining clips.

6. Install a new shift linkage pin assembly (2) and one additional retaining clip (1) into the yolk hole (3).
- 6.1 Install the linkage pin assembly (2) through the yolk hole (3).
- 6.2 Install the additional retaining clip (1) onto the linkage pin assembly end that does NOT have a retaining clip (1).
7. Install the transmission. Refer to *Transmission Replacement* in SI.
