Program Bulletin

CUSTOMER SATISFACTION PROGRAM

SUBJECT: No Start or MIL Indicator Power Reduction Mode

MODELS: 2015 Chevrolet Silverado HD
2015 GMC Sierra HD
Equipped with Duramax Diesel Engine

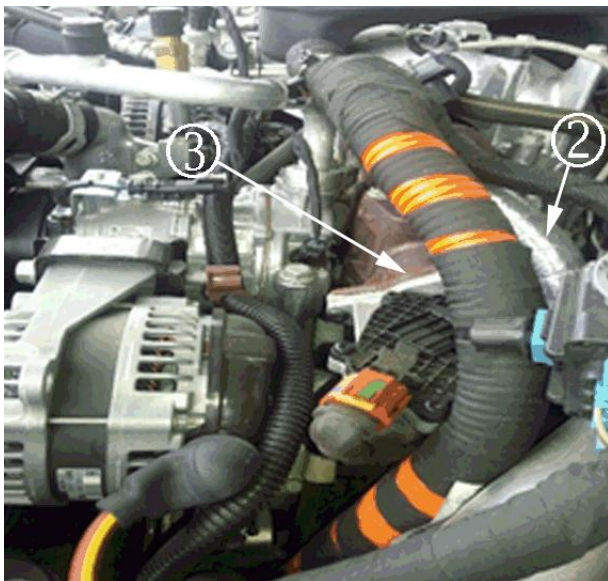
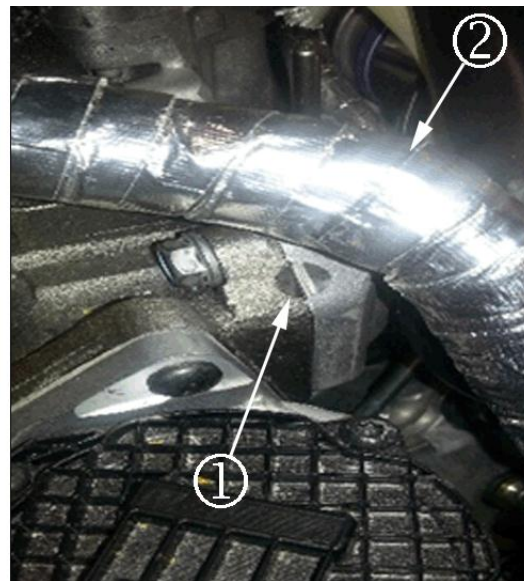
3965102

Note: The main engine wiring harness (2) can come into contact with the EGR valve gasket verification tab. The EGR valve gasket tab may cut into the engine wire harness and damage the wires.

1. Inspect the engine wiring harness (2) for a contact issue between the engine wire harness and gasket installation tab between the EGR valve and intake manifold (3).
 - If the engine wiring harness tape, conduit, or wires are cut, torn, or damaged, repair the engine wiring harness. Refer to the appropriate wire harness repair information in SI. Proceed to step 3 AFTER repairing the engine wiring harness.
 - If the engine wire harness is NOT cut or damaged, proceed to step 2.
2. Locate the gasket installation tab between the EGR valve and intake manifold (1), (3).
3. Modify the gasket installation tab (1) by butterflying the gasket installation tab flat to the EGR valve and manifold surfaces.
4. Ensure that the gasket tab has no sharp edges that can come into contact with the engine wiring harness.
