# Service Bulletin

**SUBJECT:** Service Update for Inventory and Customer Vehicles  
Power Steering Hose Leak  
Expires with Base Warranty

**MODELS:** 2015 Chevrolet Silverado 2500/3500 HD  
2015 GMC Sierra 2500/3500 HD  
Serviced Before September 9, 2014 (Pursuant to Recall Bulletin 14356)

Subject: 14608 – Service Update for Inventory and Customer Vehicles -  
Power Steering Hose Leak

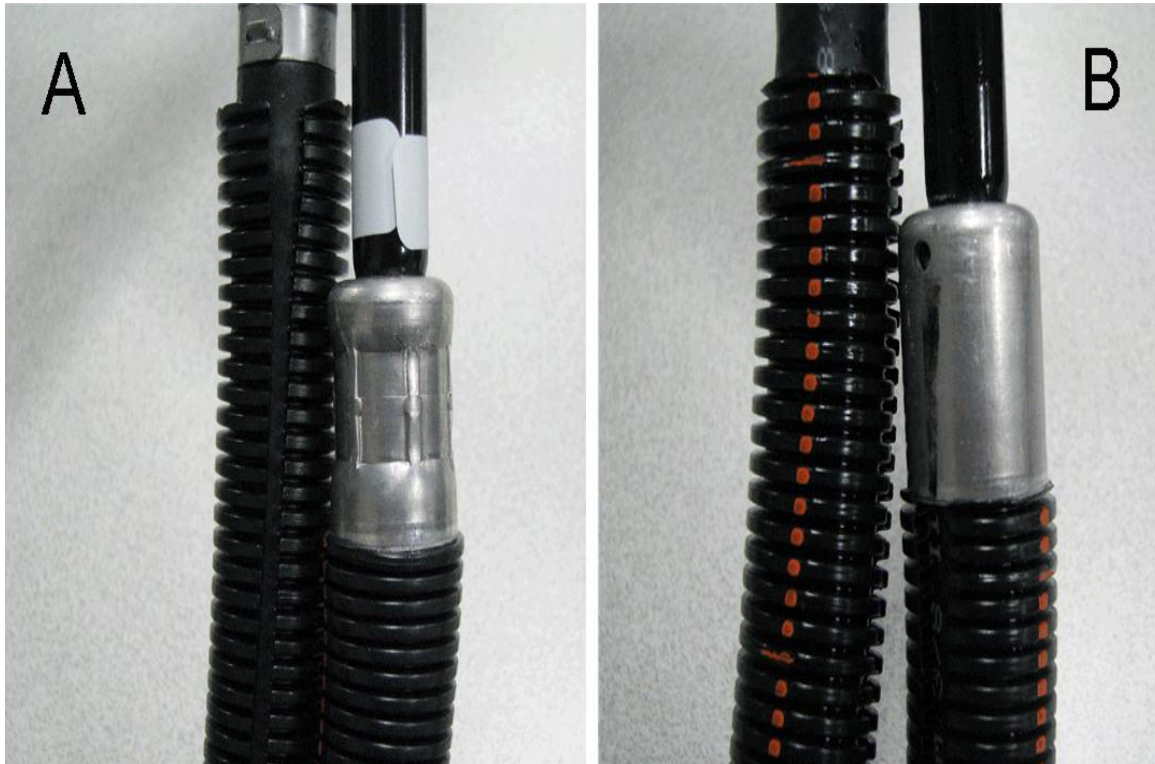
3975435

(A) Crimped ferrule with swedge marks. This is a secure connection on the pipe ferrule. (B) Uncrimped ferrule without swedge marks. This is NOT a secure connection on the pipe ferrule.

- If the power steering hose is missing a ferrule, the crimps are NOT secure or DO NOT show evidence of swedge marks, **replace the power steering fluid cooler**. Refer to *Power Steering Fluid Cooler Replacement (Heavy Duty)* in SI.
