Seat Belt Bolts, Tighten MRU

FSB 884-007, Seat Belt Bolts, Tighten

(December 2014)

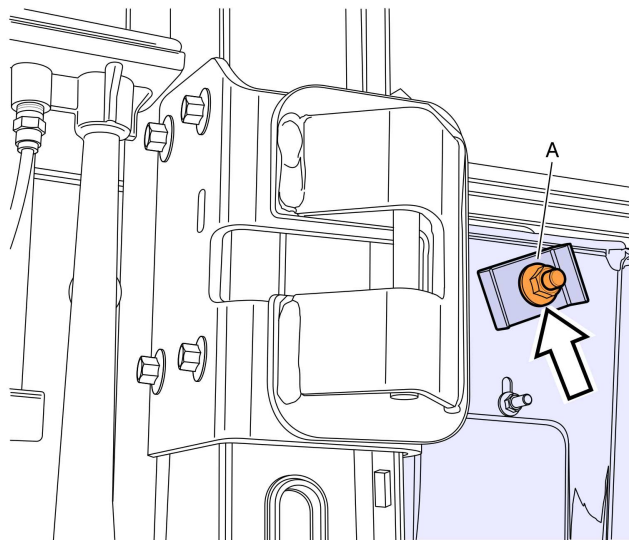
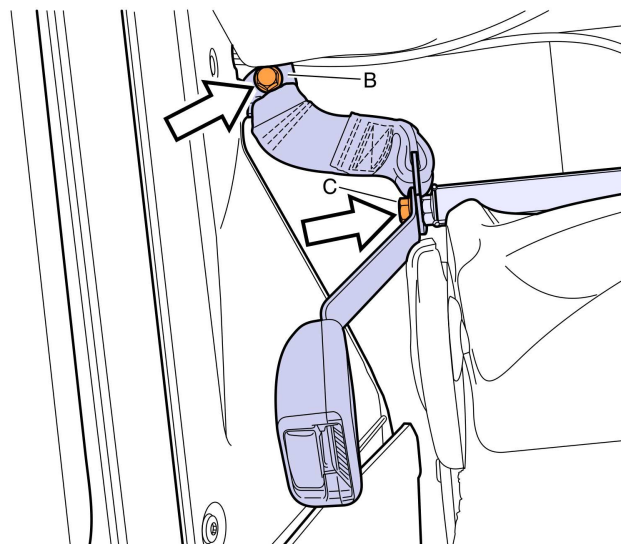
W8094419

On certain MACK MRU trucks manufactured from 06/04/2014 through 06/18/2014, the driver side seat belt bolts may loosen over time and potentially cause the seat belt to detach from the seat frame, cab wall, and cab floor. During seat belt installation, the tool used to install the seat belt bolts was out of specification, causing the application of a lower torque value than required. As a result of the lower torque values applied, the seat belt bolts may loosen over time and potentially cause the seat belt to detach. If this occurs, the seat belt may fail to restrain the occupant of the seat during the event of a vehicle crash.

- 3 Inside the cab with assistance, secure the inside fastener (B) securing the driver side seat belt tether to the cab floor and tighten the outside fastener (A) to 61 – 67 Nm (45 – 50 ft-lb).

Note: Use hand tools to tighten all seat belt fasteners.
