Vehicle Speed Sensor CHU, CXU, GU, TD

FSB 386-007, Vehicle Speed Sensor

(November 2014)

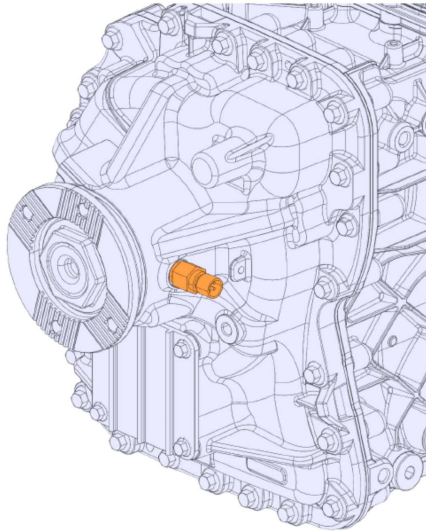
W3094986

- 4 Remove the VSS from the transmission.

Note: If a gasket or shim is present between the sensor and transmission discard it **DO NOT** reuse with new sensor.
