## Vehicle Speed Source (AZI) CXU

### PI0843, Vehicle Speed Source (AZI)

(April 2014)

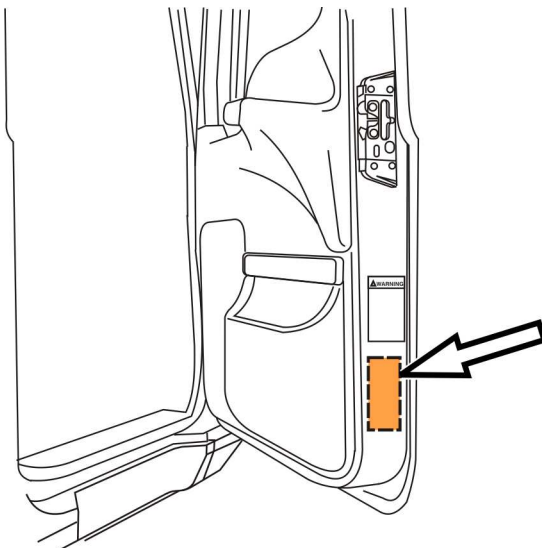
W8034103

**Note:** To signify that the campaign has been completed, using a permanent-type marker (such as a Sharpie®) write the campaign number (PI0843) and completion date in the spaces provided on the Campaign Completion label located inside the cab as shown in the illustration below. If a label is not already affixed inside the cab, apply a label (part No. TS897) and supply the information as required. Campaign Completion labels are available in packs of 50 and can be ordered by faxing a completed BR313 to Pacesetters Business Services at 610-264- 9465.
