Camelback Spring Cap, Modification CHU, CXU, GU, TD, LEU, MRU

FSB 722-002, Camelback Spring Cap, Modification

(March 2014)

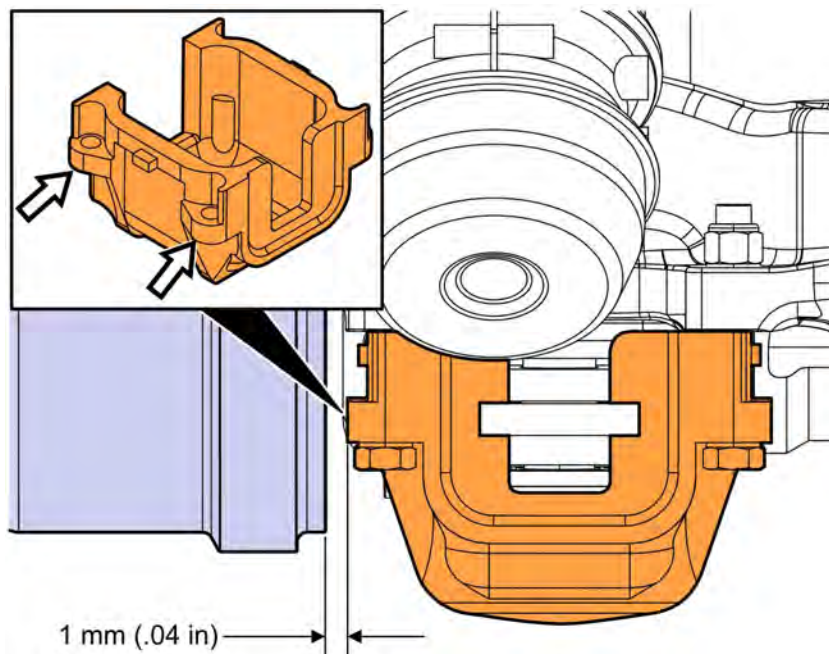
W7088547

Interference between the brake lining and the spring cap was discovered on some MACK CHU, CXU, GU, TD, LEU, MRU trucks equipped with 203 mm (8 in) rear drum brakes and camelback rear suspension. The suspected trucks were built between 01/01/2007 and 04/01/2014. If there is a nominal clearance of 1 mm (.04 in) between the brake lining and the spring cap, there will be no signs of interference on the spring cap. Trucks with less than a nominal clearance of 1 mm (.04 in) will display signs of interference and require modification to the spring cap boss. The modification will include grinding excess material off of the spring cap boss until a nominal clearance of 1 mm (.04 in) is achieved.

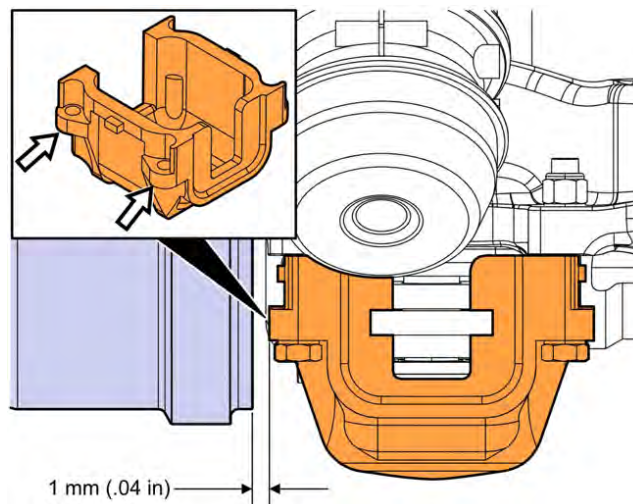
W7088547

- 6 Inspect each of the rear wheel ends for interference between the brake lining and the spring cap.

Note: A clearance of 1 mm (.04 in) between the brake lining and the spring cap passes inspection.

Note: A clearance of less than 1 mm (.04 in) between the brake lining and the spring cap fails inspection.

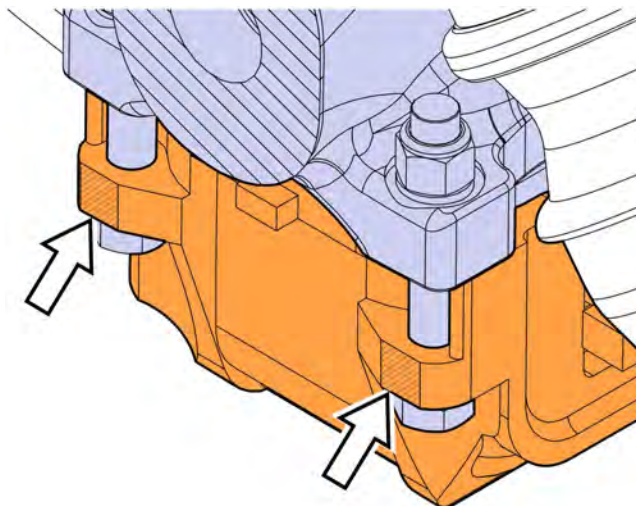
W7088554

Grinding excessive material from the spring cap boss may result in a later failure due to a weakened spring cap.

- 9 Grind no more than 4 mm (0.16 in) of material from the spring cap boss.

- 10 Apply paint to the bare metal area of the spring cap boss to protect it from rust.
