## Cab Harness Insulation, Installation CHU, CXU, GU, TD

### FSB 371-048, Cab Harness Insulation, Installation

(October 2014)

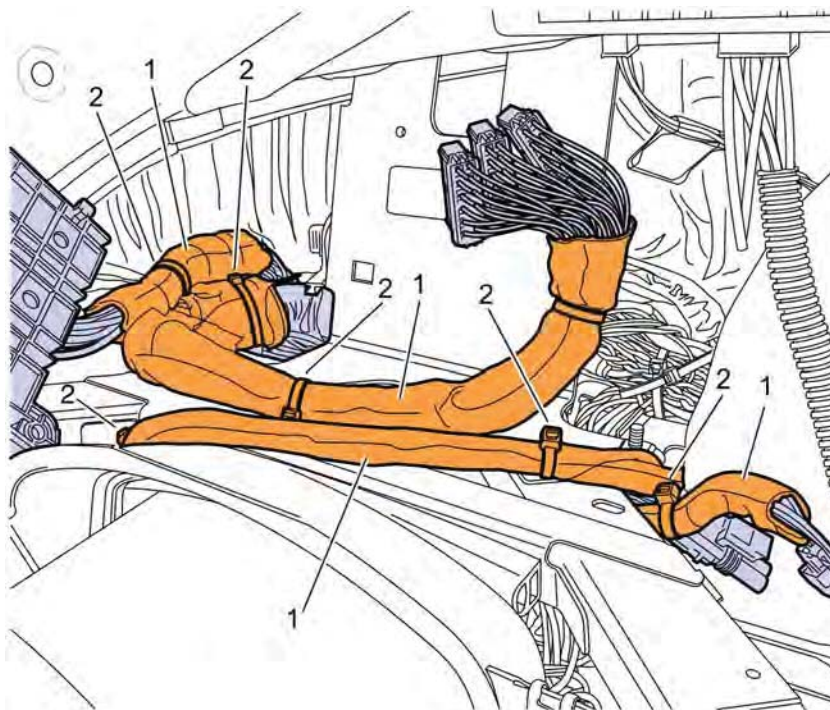
W3093293

In some MACK CXU, CHU, GU, and TD trucks built between 01/01/2007 and 10/03/2014, the cab wiring harness may experience chafing in or around the steering column bracket. A self-wrapping insulation kit has been introduced to protect the cab wiring harness from chafing. The kit contains sections of insulation in 50 mm (2.0 in), 25 mm (1.0 in), and 13 mm (.5 in) diameter sizes. The insulation can be cut to desired lengths and wrapped around the harness areas in contact with the steering column bracket. Each section of insulation is secured using cable ties as needed.
