## Compressor Discharge Line LEU, MRU

### FSB 561-024, Compressor Discharge Line

(February 2014)

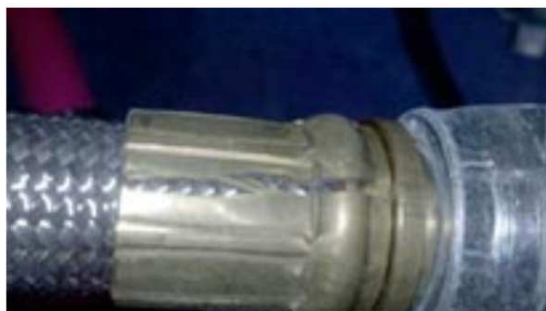
W5085642

On LEU633 and MRU633 models built between March 2012 and August 2013 the brass collar that is crimped onto the stainless steel compressor discharge line may split, resulting in the inability of the unit to build air pressure. The original part numbers of the Stainless Steel line assembly that are affected are: 25195537, 25192424, and 21628882. Should a failure occur the discharge line should be replaced with the new compressor discharge lines that have a steel collar.

- 1 Raise the cab.
- 2 Remove clamps securing main air line.
- 3 Disconnect braided line.
- 4 Install the replacement braided line. Tighten securely.
- 5 Install clamps securing main air line.
- 6 Start engine. Build air to maximum pressure and check for leaks.
- 7 Lower cab.
