ID: IK1201113

Title: 2010 MaxxForce 11 & 13 and 2013 N13 HT EGR Core Removal/Installation

Applies To: 2010 MaxxForce11/13, 2013 N13, All Truck Models

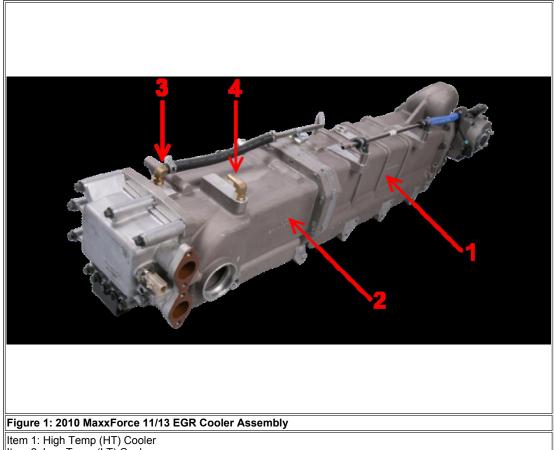
Item 2: Low Temp (LT) Cooler

Item 3: LT Cooler Pressure Test Port (dearation fitting)
Item 4: HT Cooler Pressure Test Port (dearation fitting)

Visual inspection should never be used for diagnosing a bad cooler. The cooler (especially when constantly operated cold--read, moving the truck around the lot) will cause condensation build-up, and when mixed with soot/exhaust constituents, can be easily confused with coolant. ALWAYS pressure test the cooler.

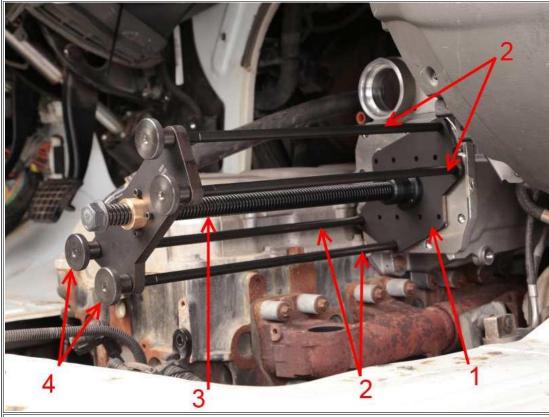
Figure 2: HT Core Removal Tool

Item 1: Removal plate

Item 2: Support rods

Item 3: Forcing screw

Item 4: Thumb screws

a. Screw in the support rods in the two upper right, and lower, bottom left corner, holes (Figure 2, Item 2). Tighten using a 9mm open-end wrench.

It is critical that the rods get torqued to the housing. There is a bevel between the threads and the shaft, designed specifically to drive the cooler header onto the shaft. Failure to do so will lead to the header being caught on the rod and breaking/bending the rod. There have been instances of the housing being damaged to the point of replacement, as well.

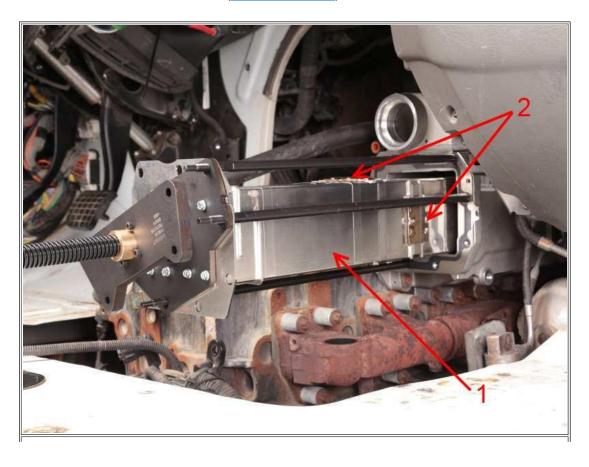
Figure 4: High Temp Core and Spring Clips

Item 1: HT Cooler Core Item 2: Spring Clips

There are two pairs of spring clips supporting the core in the housing. Therefore, the core will need to be pulled about 16 inches before it will be free to remove.

5. Back out the bolt to extract the core from the housing (counter-clockwise).

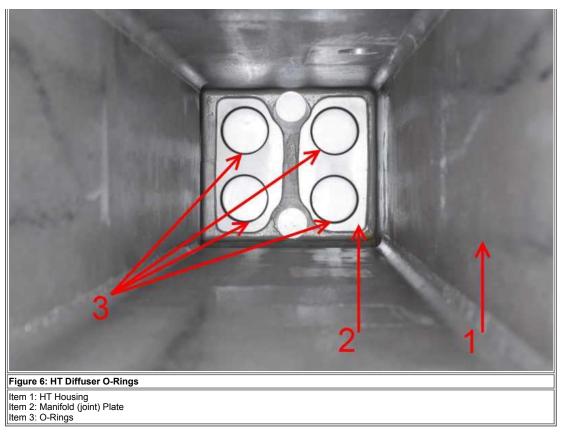
Make sure there is no debris in the o-ring grooves prior to installing the o-rings (they don't need to be spotless, just no soot chunks that will push the o-ring out of round). In development, this was the only instance of damaged o-rings (core outlet manifold cut off a section of the o-ring), outside of not actually seating them.

1. Install the four o-rings from the HT kit (Figure 6, Item 3) and ensure they are seated properly.

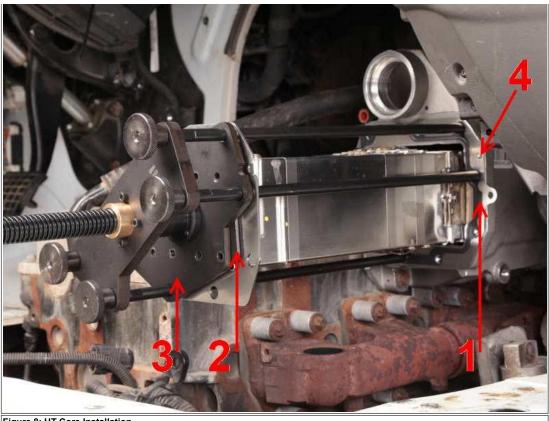
Figure 8: HT Core Installation

The core should take up to 10 lb-ft of bolt torque to slide in. Damage to the tubes will occur if the torque exceeds 15 lb-ft (equates to 1000 lb force).

- Item 1: Core to Housing Gasket
- Item 2: Installation Plate
- Item 3: Removal Plate
- Item 4: Dowel Pin
- 6. Apply liberal amounts of P-80 to the outlet manifold and spring clips of the HT core.
- 7. Slide the HT Core into the housing.
- Attach the insertion plate to the tool and slide it over the rods.
- Screw the thumbscrews onto the rods.
- 10. Use a torque wrench to tighten the bolt, which will drive the core into the housing. Stop when the core header touches the gasket.

DO NOT OVER TIGHTEN. Stop when the plate merely touches the gasket/housing.
