Countries:	CANADA, COLOMBIA, UNITED STATES, MEXICO, PUERTO RICO	Document ID:	IK0800463
Availability:	ISIS	Revision:	3
Major System:	ELECTRICAL SYSTEM	Created:	11/4/2013
Current Language:	English	Last Modified:	7/15/2014
Other Languages:	NONE	Author:	Ken Fogelstrom
Viewed:	841

Title: High or Spiking Voltage w/ Leece-Neville Alternator Using Remote Voltage Sense

Applies To: Feature codes: 08GXD; 08GXE; 08GXC; 08GXB Build date range: Apr 1, 2013 - Nov 11, 2013

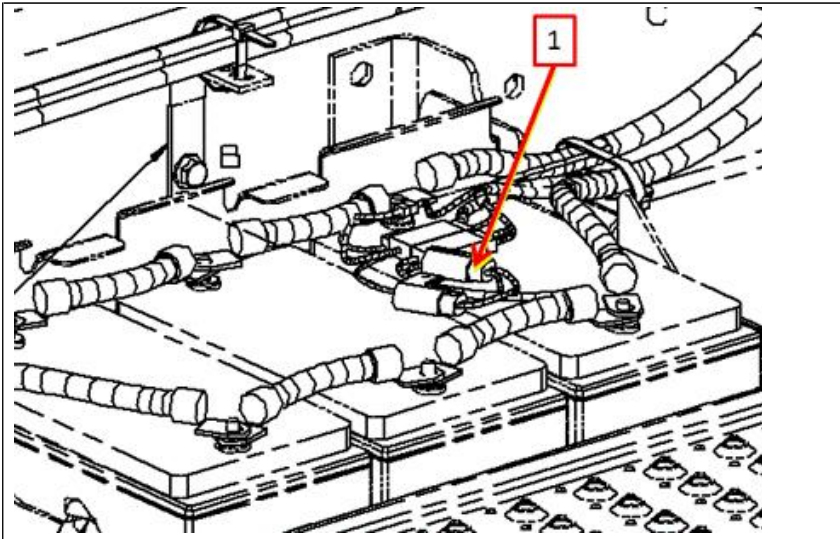
1) Remote sense fuse

For most configurations, the fuse will be found strapped to positive battery cable inside or near the battery box (Fig 1).

2. Check continuity between remote sense battery connection and alternator "S" terminal to verify correct wire and fuse (Figs 1+3).
3. Remove fuse from socket.
4. Replace fuse socket cap.

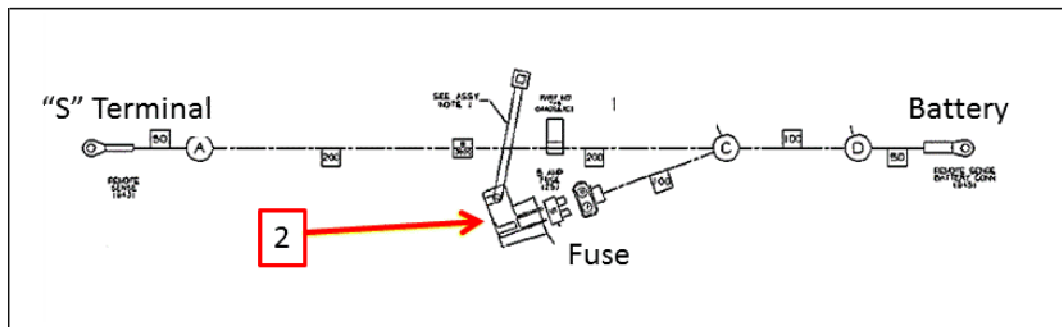
2) Remote sense harness and fuse

If not, trace the sensor wire back from the battery until the fuse is located (Fig 2).
