<b>Countries:</b>	AUSTRALIA, CANADA, UNITED STATES, MEXICO, PUERTO RICO	<b>Document ID:</b>	IK1201113
<b>Availability:</b>	ISIS, FleetISIS	<b>Revision:</b>	5
<b>Major System:</b>	ENGINES	<b>Created:</b>	4/3/2014
<b>Current Language:</b>	English	<b>Last Modified:</b>	7/22/2014
<b>Other Languages:</b>	NONE	<b>Author:</b>	Aaron Wenthold
<b>Viewed:</b>	2472

**Title: 2010 MaxxFORCE 11 & 13 and 2013 N13 HT EGR Core Removal/Installation**

**Applies To: 2010 MaxxFORCE11/13, 2013 N13, All Truck Models**

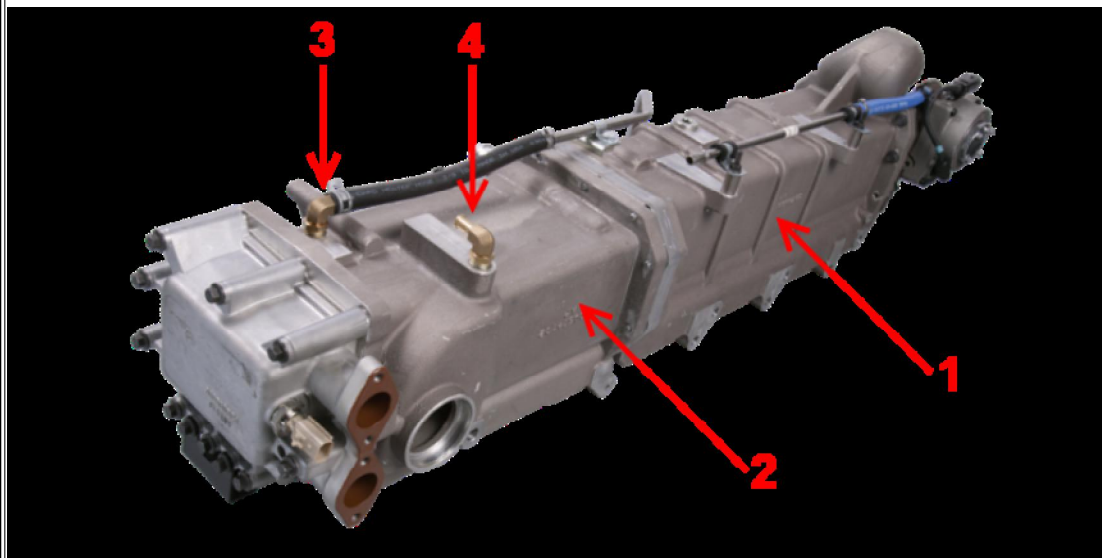
**Figure 1: 2010 MaxxForce 11/13 EGR Cooler Assembly**

- Item 1: High Temp (HT) Cooler
- Item 2: Low Temp (LT) Cooler
- Item 3: LT Cooler Pressure Test Port (dearation fitting)
- Item 4: HT Cooler Pressure Test Port (dearation fitting)

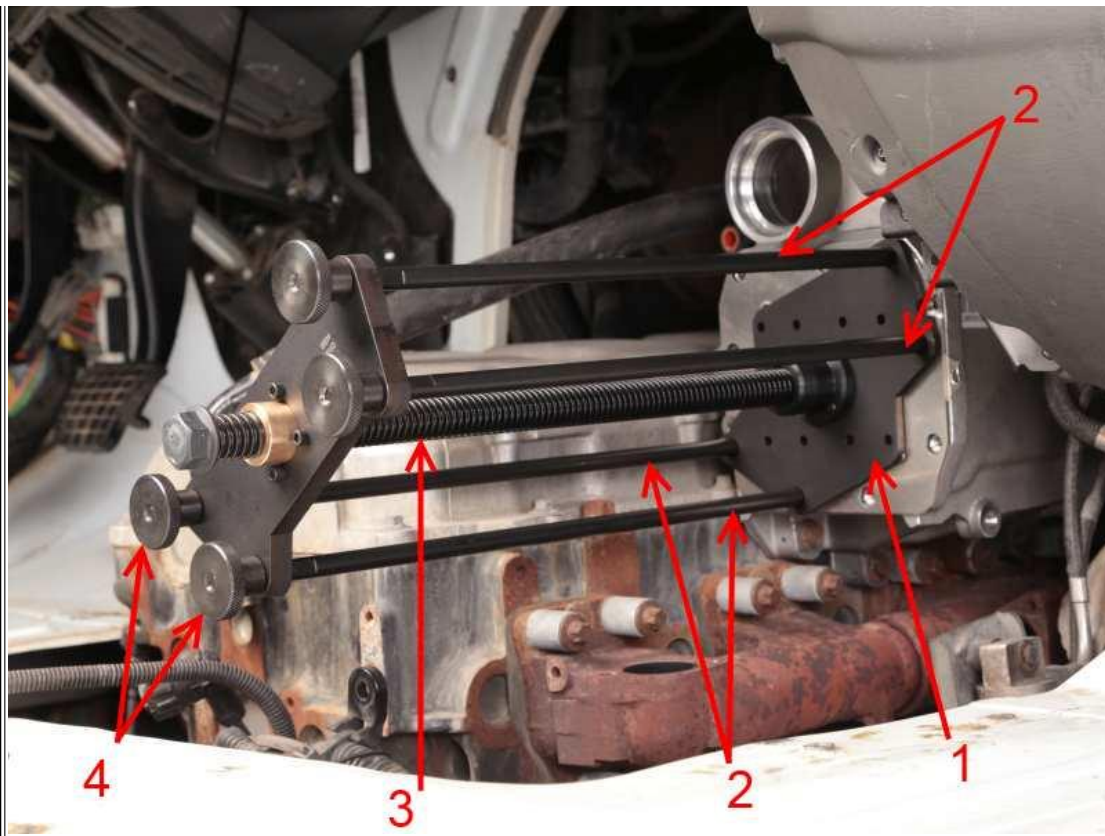
**Figure 2: HT Core Removal Tool**

- Item 1: Removal plate
- Item 2: Support rods
- Item 3: Forcing screw
- Item 4: Thumb screws

It is critical that the rods get torqued to the housing. There is a bevel between the threads and the shaft, designed specifically to drive the cooler header onto the shaft. Failure to do so will lead to the header being caught on the rod and breaking/bending the rod. There have been instances of the housing being damaged to the point of replacement, as well.

a. Screw in the support rods in the two upper right, and lower, bottom left corner, holes (**Figure 2**, Item 2). **Tighten using a 9mm open-end wrench.**

- b. Slide the puller over the rods
- c. Attach/tighten the thumb screws (**Figure 2**, Item 4).

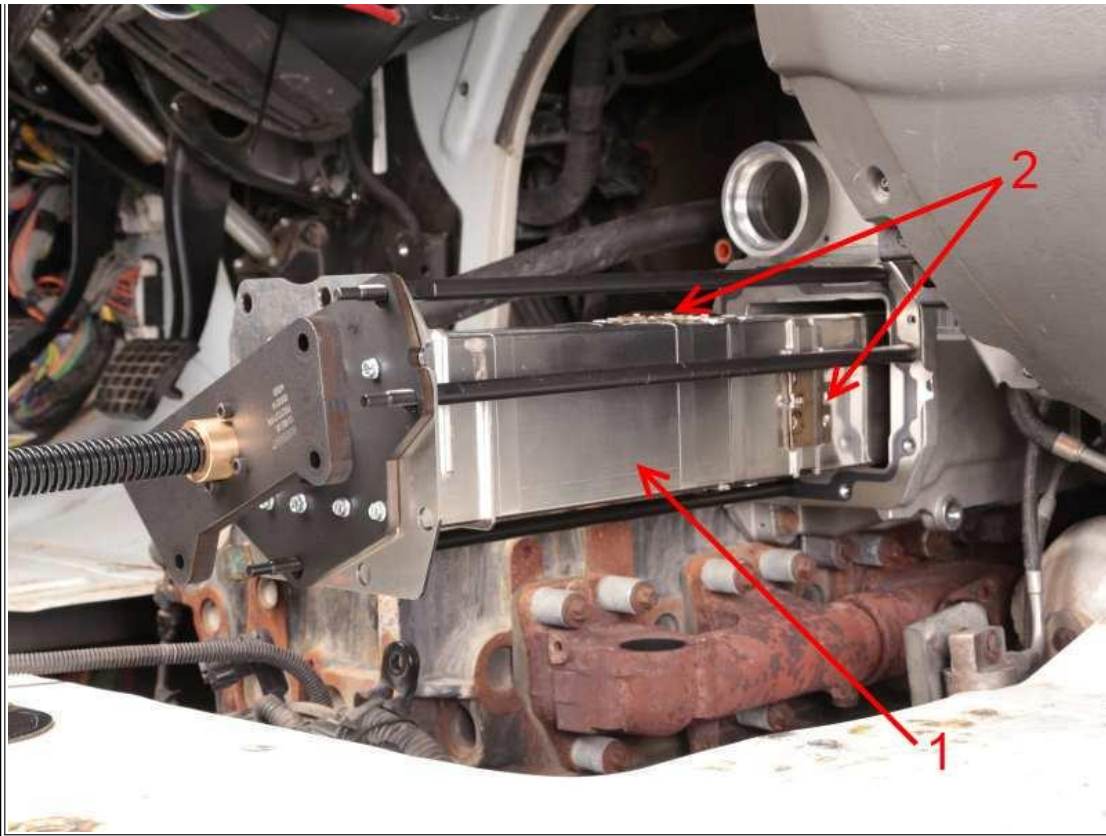
**Figure 4: High Temp Core and Spring Clips**

Item 1: HT Cooler Core  
 Item 2: Spring Clips

There are two pairs of spring clips supporting the core in the housing. Therefore, the core will need to be pulled about 16 inches before it will be free to remove.

5. Back out the bolt to extract the core from the housing (**counter-clockwise**).

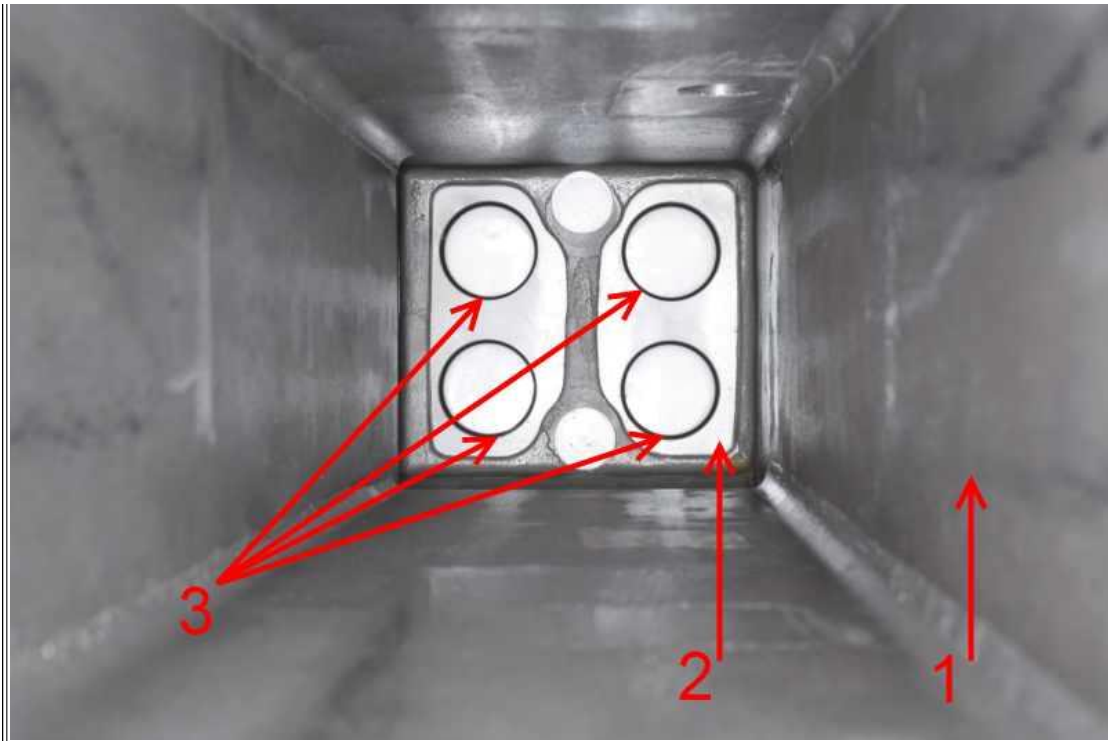
Figure 5: HT Diffuser O-Rings

- Item 1: HT Housing
- Item 2: Manifold (joint) Plate
- Item 3: O-Rings

10. Use a pick to remove the four o-rings in the center of the cooler and discard. *The o-rings must be replaced every time the core is replaced. Non-compliance will result in premature failure of the core.*

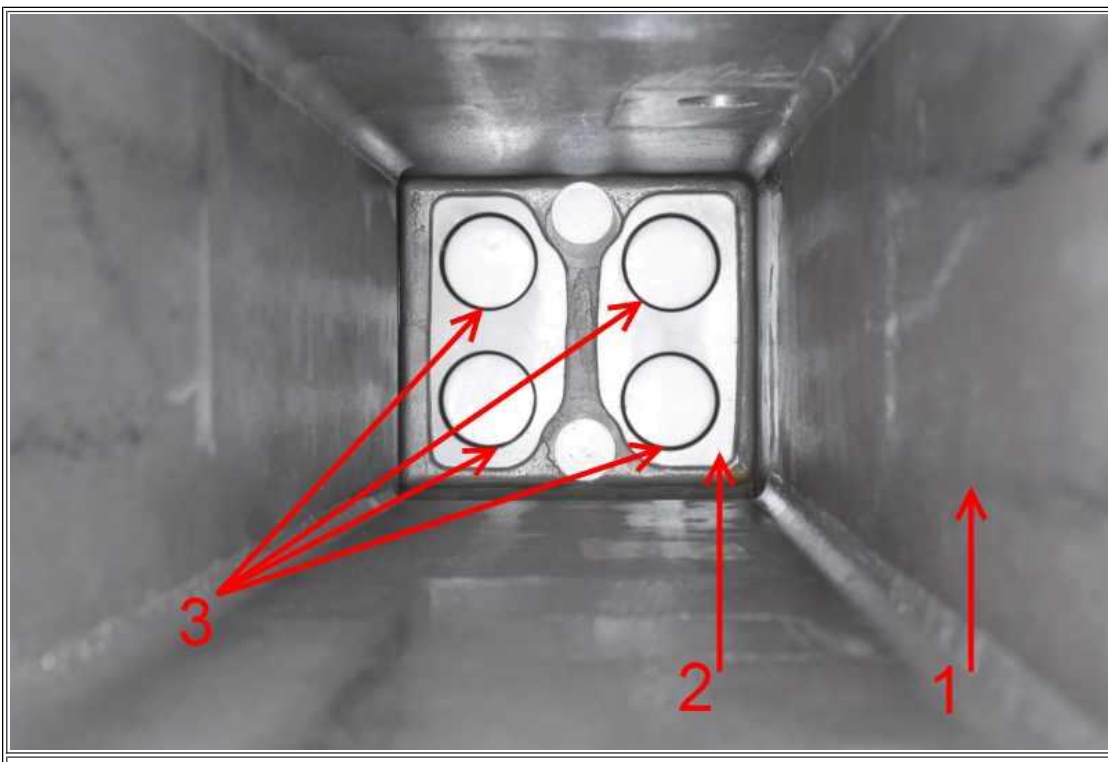
**Figure 6: HT Diffuser O-Rings**

- Item 1: HT Housing
- Item 2: Manifold (joint) Plate
- Item 3: O-Rings

**Make sure there is no debris in the o-ring grooves prior to installing the o-rings** (they don't need to be spotless, just no soot chunks that will push the o-ring out of round). In development, this was the only instance of damaged o-rings (core outlet manifold cut off a section of the o-ring), outside of not actually seating them.

1. Install the four o-rings from the HT kit (**Figure 6**, Item 3) and ensure they are seated properly.

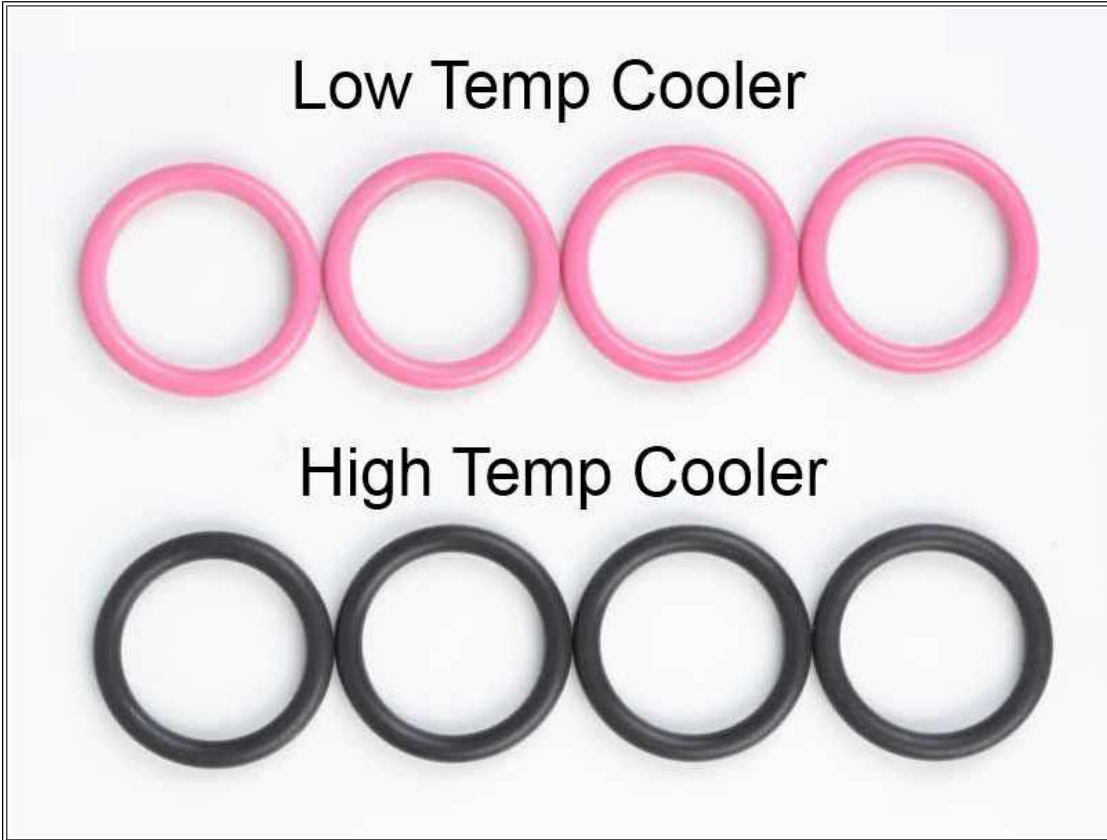
**Figure 7: Cooler Core Kit O-Rings**

There are two o-ring designs and both are the same size with different durometers. Make sure to use only the black o-rings on the HT core and pink o-rings on the LT core.

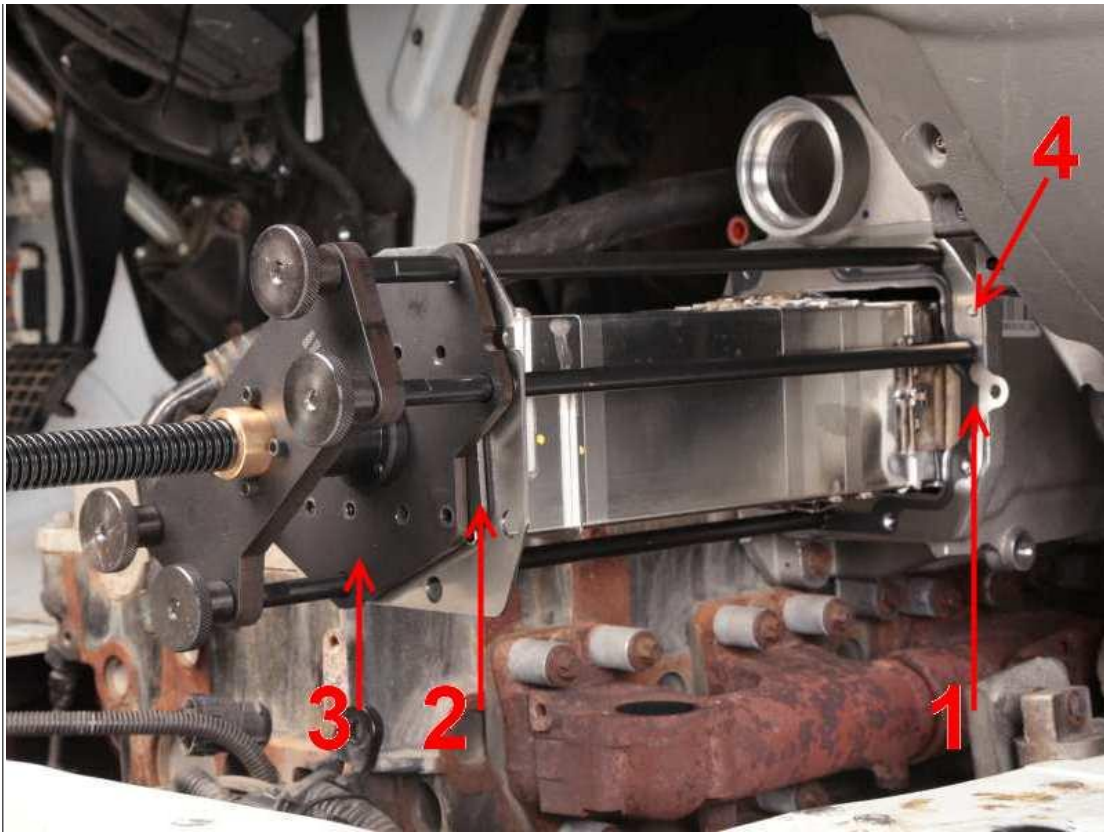
**Figure 8: HT Core Installation**

- Item 1: Core to Housing Gasket
- Item 2: Installation Plate
- Item 3: Removal Plate
- Item 4: Dowel Pin

**DO NOT OVER TIGHTEN.** Stop when the plate merely touches the gasket/housing. The core should take up to 10 lb-ft of bolt torque to slide in. **Damage to the tubes will occur if the torque exceeds 15 lb-ft (equates to 1000 lb force).**

6. Apply liberal amounts of P-80 to the outlet manifold and spring clips of the HT core.
7. Slide the HT Core into the housing.
8. Attach the insertion plate to the tool and slide it over the rods.
9. Screw the thumbscrews onto the rods.
10. Use a torque wrench to tighten the bolt, which will drive the core into the housing. Stop when the core header touches the gasket.
