Document ID: IK1400033
Revision: 1
Created: 3/24/2014
Last Modified: 7/7/2014
Author: Pablo Guerrero

Title: Torque change for 5/8 inch rear axle shaft flange mounting stud with cone locks and flat washer type hardware.

Applies To: 1652, BE 200, CE 200, CE 300, FE 300, RE 200, RE 300, 4100, 4200, 4300, 4400, 5500i, 5600i, 5900i, 7300, 7400, 7500, 7600, 7700, 8500, 8600, 9200i, 9400i, 9900i, CT630, CT610, Prostar.

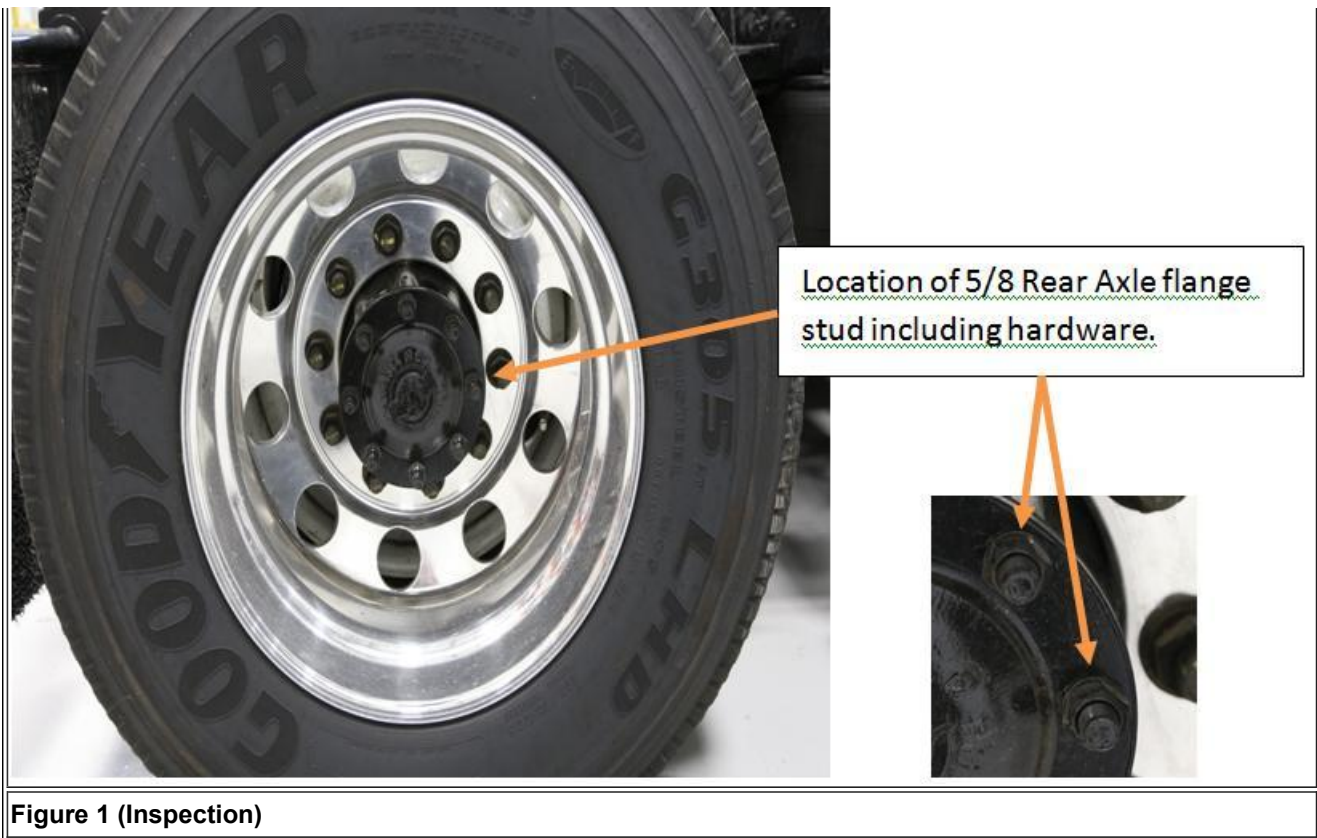
- 5/8 inch rear axle flange stud missing or loose.
- Rear axle flange leaking due to missing or loose stud hardware.

- 1) Inspect for missing or loose 5/8 axles shaft hardware (Figure 1).
- 2) If any loose or missing hardware is found, replace missing 5/8 rear axle flange hardware
- 3) Re-torque all 5/8 rear axle flange hardware to 145 - 175 ft*lbs using correct torque sequence (Figure 2)
