SERVICE BULLETIN

APPLICABILITY:	2010-2013MY Legacy and Outback
	Dan Cound from Dight Door Whool Anron A

SUBJECT: Pop Sound from Right Rear Wheel Apron Area

NUMBER: 12-147-13R DATE: 03/08/13 REVISED: 06/18/14

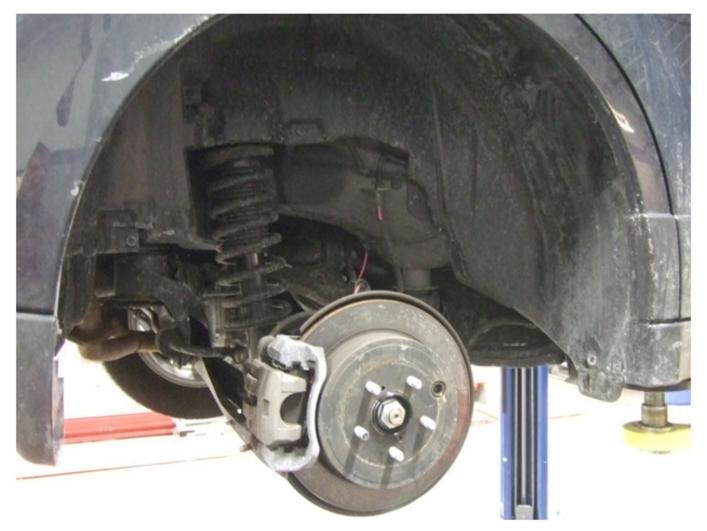
- 1. Remove the right rear wheel assembly.
- 2. Remove the right rear inner mud guard which is attached by 12 clips (10 small 2 medium). Note the orientation of the clips prior to removal.

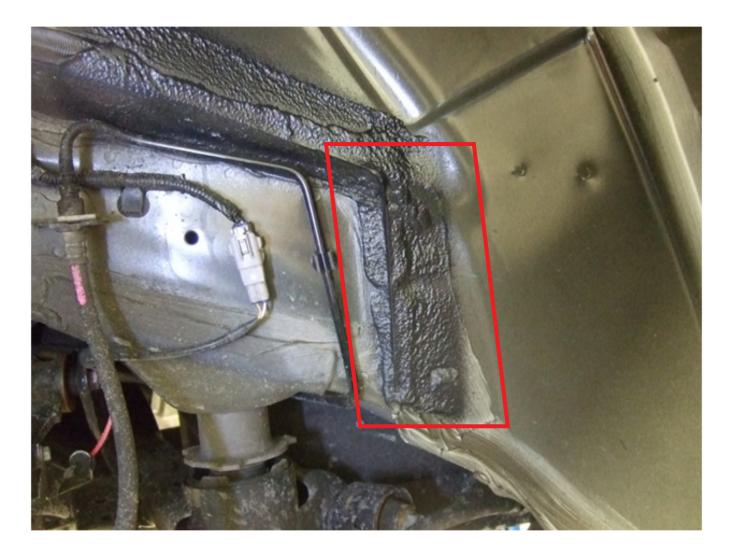
The undercoating needs to be removed from the area outlined.

3. Remove the undercoating using a right angle disc sander and surface grinding disc. **NOTE:** Safety glasses and a respiratory mask should be worn when performing the procedures listed in this Service Bulletin.

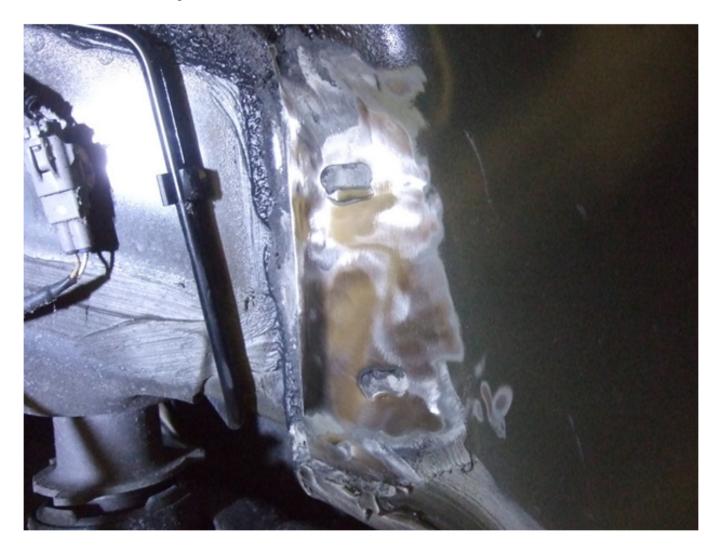
There are 3 layers of sheet metal which are secured together.

Outer - Wheel apron rear

Middle – Side sill inner rear

Inner – Frame side rear lower front

The outer wheel apron is secured by 2 welds to the middle side sill.

The middle side sill is secured by 6 welds to the inner frame.
