Countries: AUSTRALIA, CANADA, CHILE, COLOMBIA, UNITED STATES, MEXICO, PERU, PUERTO RICO
Document ID: IK1600207
Availability: ISIS, FleetISIS
Revision: 0
Major System: CAB / SLEEPER / HOOD
Created: 6/5/2014
Current Language: English
Last Modified: 7/14/2014
Other Languages: NONE
Author: Jeff McIntosh
Viewed: 118

Title: Wind noise at upper side door

Applies To: All steel cabs: ProStar, LoneStar, TranStar, WorkStar, DuraStar, TerraStar

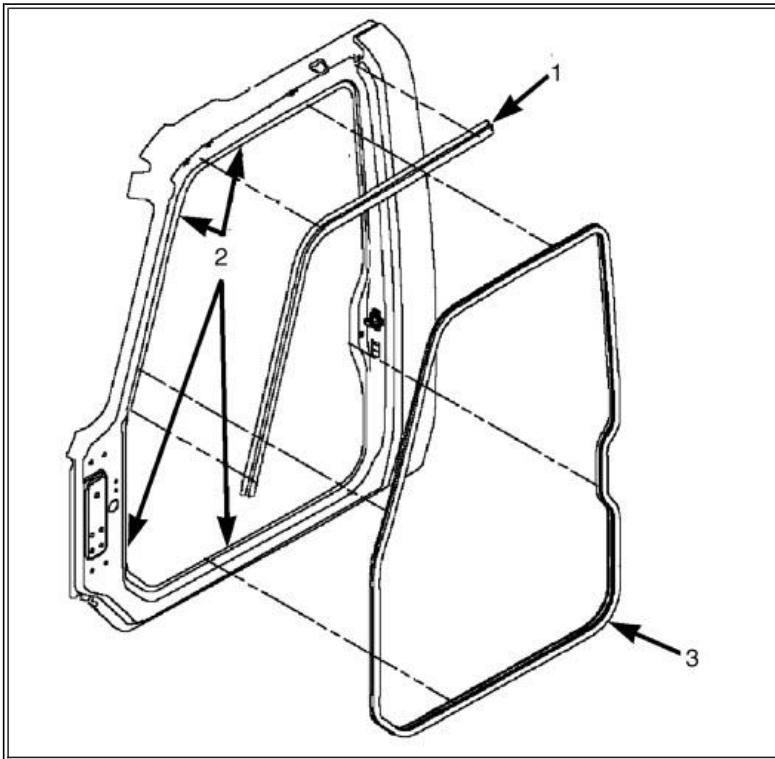
Figure 1: Door Seals

There are instances when the cab side entry door does not have proper contact with the door seals along the top of the door causing wind noise and/or flutter. In extreme cases and in inclement weather, there could be water intrusion as well. Many design improvements were made between 2004 and 2009 that drastically improved quality in this area, however there are still isolated occurrences when this issue still persists.

1. Inspect the primary (Figure 1, Item 3) and secondary (Figure 1, Item 1) door seals. Ensure they are seated down completely. If there is any visible damage or waves, adjust or replace as necessary.
2. Inspect the door to ensure proper positioning and flushness within the door frame. Refer to the master service manual under "Adjustments: Cab Door" (general information), "Adjustments: Door Hinge" (affects door positioning), and "Adjustments: Striker Pin" (affects door flushness).

3. After replacing or adjusting any of the parts in steps 1 or 2, remove the primary door seal (Figure 1, Item 3).
4. While closing the door, place a dollar bill or similar size/shape piece of paper between the secondary door seal (Figure 1, Item 1) and the door (Not Shown) at the base of the A-pillar where the secondary door seal starts/terminates just above the upper door hinge (Figure 2, Item 1).

5. Slide the dollar bill up and along the door all the way back to the upper rear corner of the door.
6. If the dollar bill does not slide freely, there is proper contact between the door and seal and no shimming is required. Reinstall the primary door seal (Figure 1, Item 3), ensuring that it is completely seated all the way around the door perimeter. The job is complete.
