WARRANTY BULLETIN

Subject: **Spyder™**

No. **2013-9**

A - Seal the Front Fuse Boxes

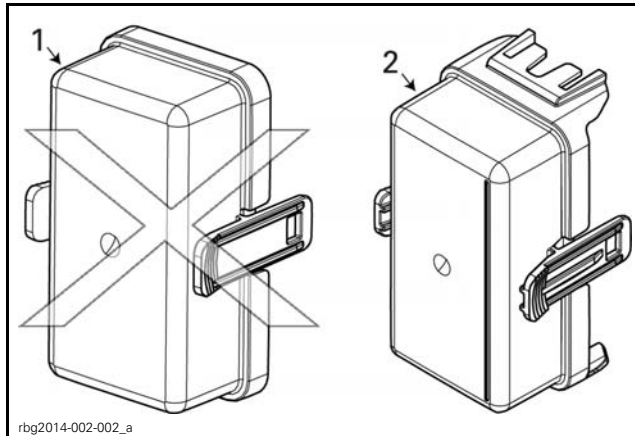
1. Old fuse box cover
2. New fuse box cover

1. Remove old covers.

2. Transfer fuses to new covers.

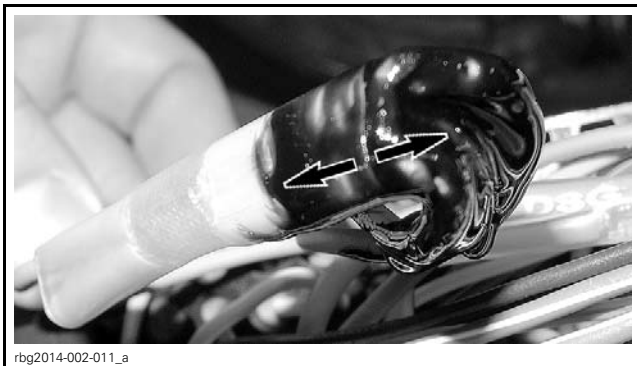
TYPICAL LIQUID TAPE APPLICATION

Water may infiltrate either of the front fuse boxes. The source of the infiltration may be:

1. The fuse box cover.
2. The bus-bar connection behind fuse box
3. Any of the wire splices behind fuse box.

5. Seal both ends of all the wire splices with liquid tape.

NOTE: Extend liquid tape onto wires and push the liquid tape into both ends of the splice for a good seal.

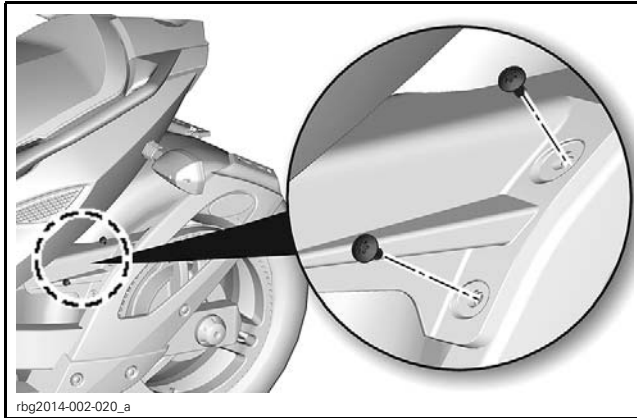
Retaining screws may not secure the belt guard properly.

Remove and discard screws on vehicle and replace with new screws.

TIGHTENING TORQUE	
Upper belt guard retaining screws	5 N•m ± 7 N•m (44 lbf•in ± 62 lbf•in)
