SERVICE BULLETIN

APPLICABILITY: 2013MY Legacy and Outback 2.5L Models
 2012-13MY Impreza 2.0L Models
 2013MY XV Crosstrek
 2011-2014MY Forester
 2013MY BRZ

NUMBER: 11-130-13R
DATE: 04/05/13
REVISED: 01/28/14

SUBJECT: Difficulty Starting, Rough Idle, Cam Position or Misfire DTCs
 P0340, P0341, P0345, P0346, P0365, P0366, P0390, P0391,
 P0301, P0302, P0303 or P0304

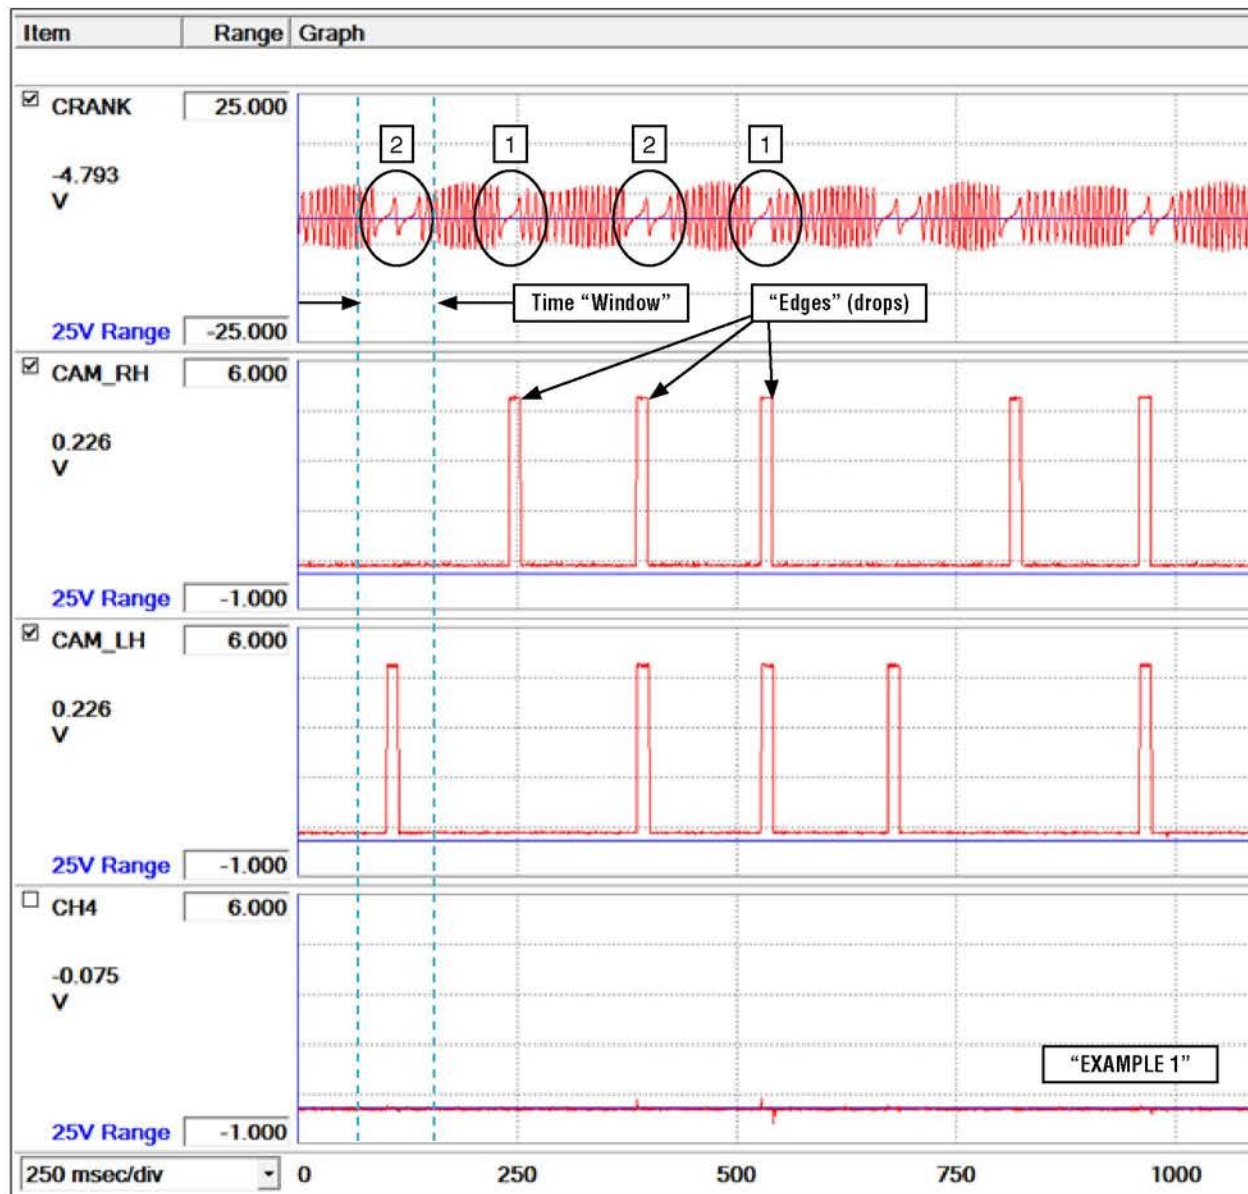
Engine Firing Order	#1	#3	#2	#4
Crank Signal ("1" or "2"?)	"1"	"2"	"1"	"2"
Is Cam Signal Edge Within Window RH?	Yes	No	Yes	Yes
Is Cam Signal Edge Within Window LH?	Yes	Yes	No	Yes

Using the chart above and comparing it to **Example 1**, it can be determined the first cylinder shown in the screen shot is #3 because the crank signal is a "2" and there is an edge signal within the window on the LH but not the RH cam sensor. Next cylinder in the firing order would be #2 as the crank position signal is a "1" and there is an edge signal in the window for the RH but not for the LH, and so on...

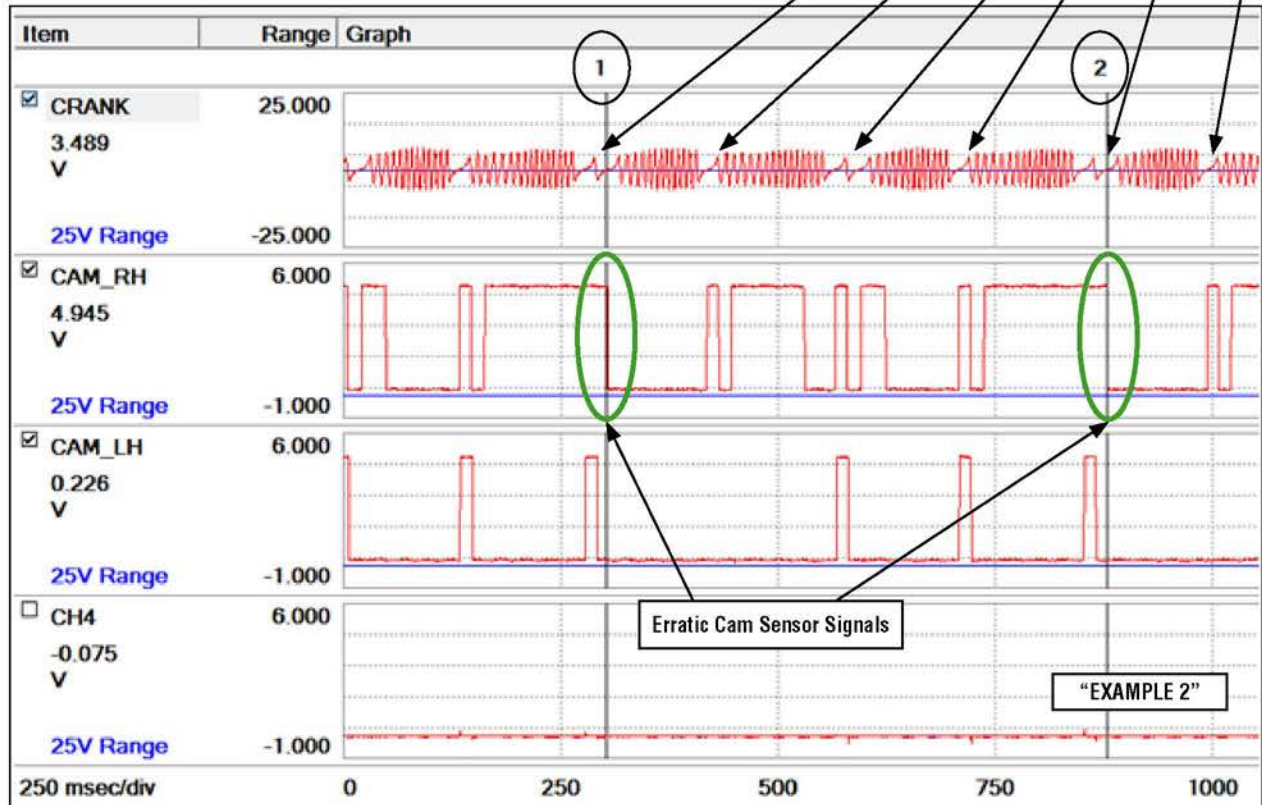
Example 2 below shows a “Bad” pattern for the RH cam sensor. Marks #1 and #2 show what appears to be #4 cylinder firing but, the next cylinder to fire according to the screen shot is #2 followed by #4 then #1. The pattern for the RH sensor never shows the proper sequence to fire #3 cylinder. In this case, recheck the data again after installing a .2mm shim under the RH cam sensor.

Proper Firing Order is: #3 #2 #4 #1 #3 #2

Firing Order shown in screen shot: #4 #2 #4 #1 #4 #2

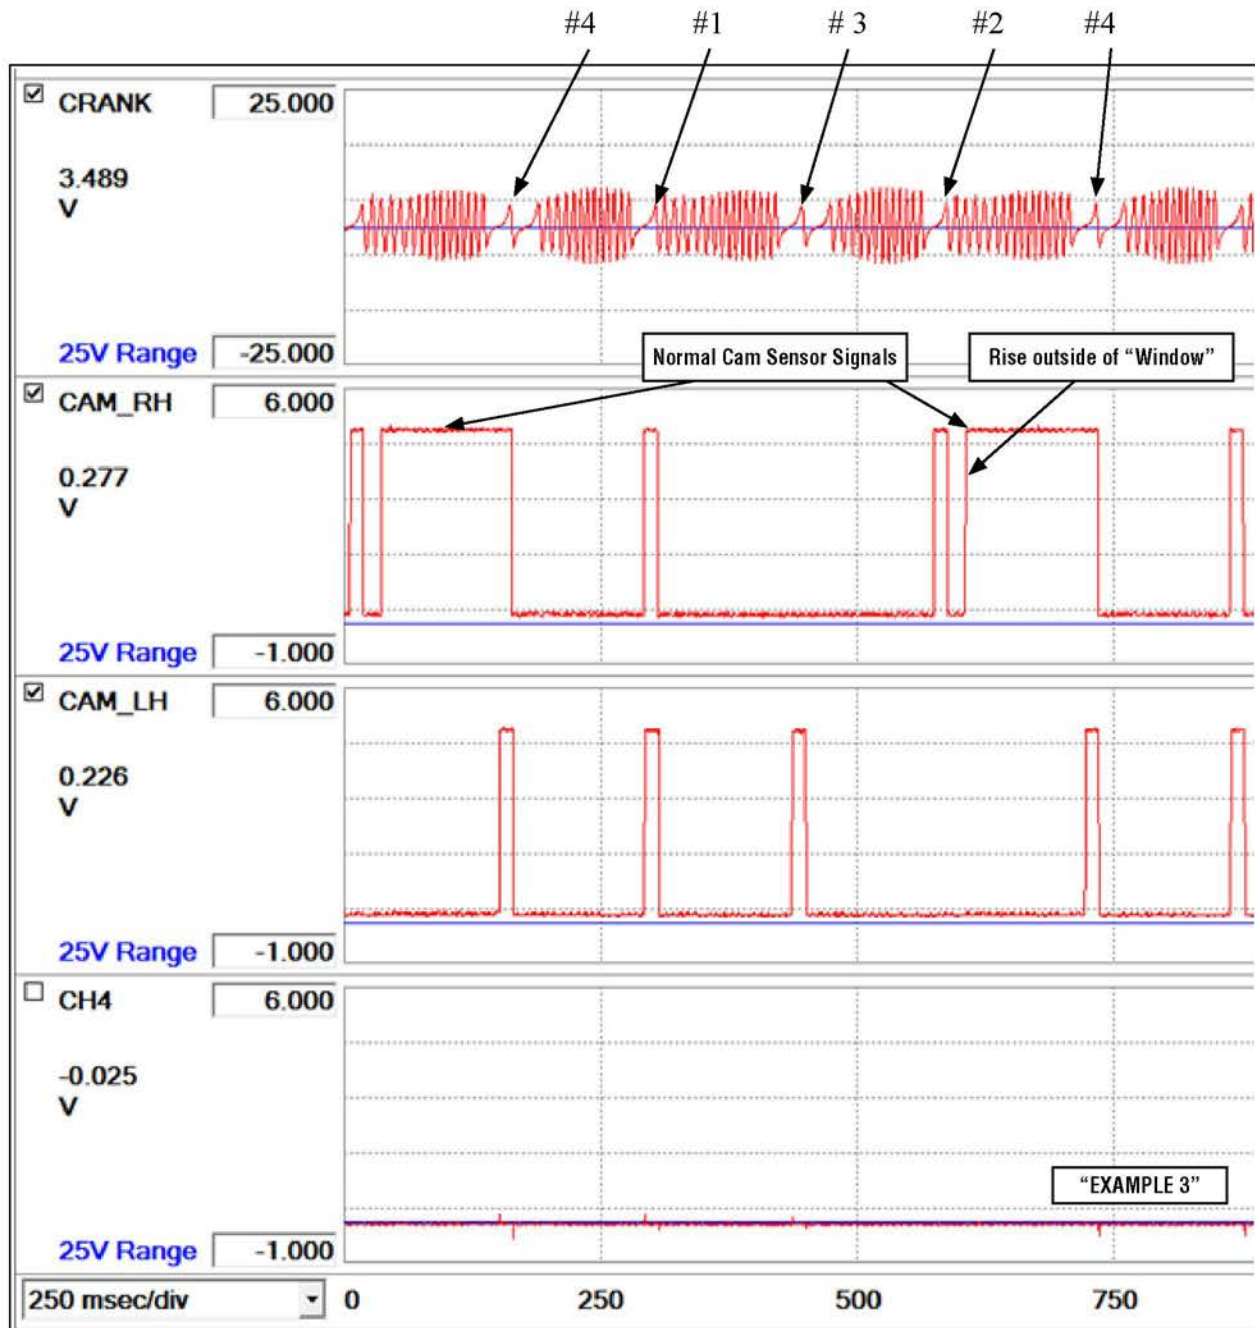
Example 3 shows what *appears* to be an erratic signal from the RH cam sensor but, you can see all the cam sensor data signal edges (drops) follow the chart and firing order as they are supposed to. Other signal edges (rises or drops) outside the “window” or a longer time line as shown here prior to the #4 signal edges seen on the RH cam sensor pattern are examples of signals which will be “ignored” by the ECM and are not a cause for concern.

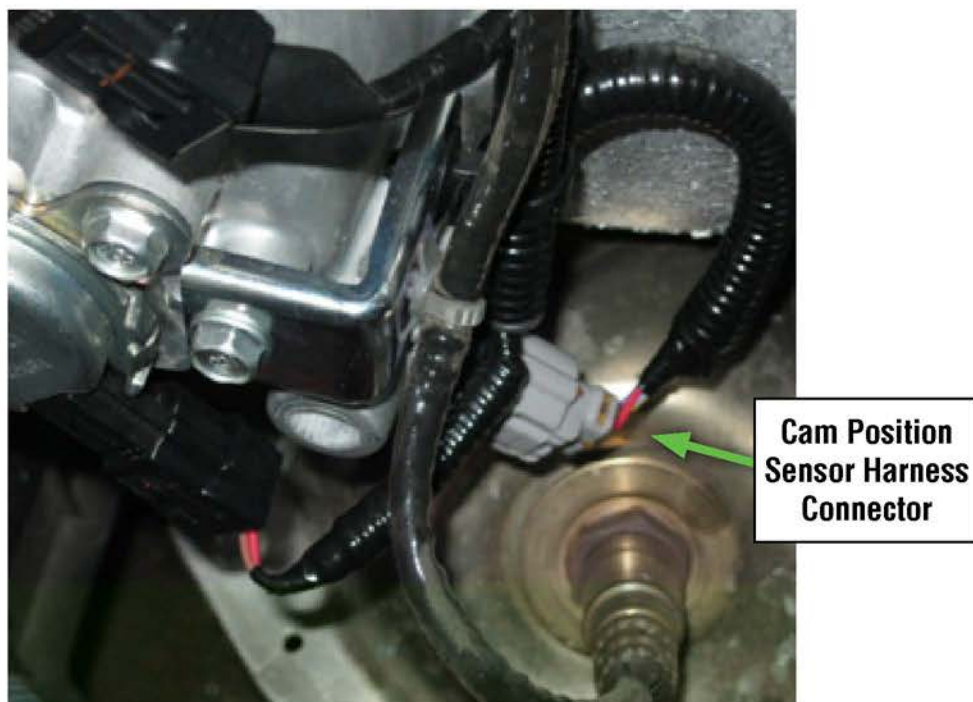
In the event you have a DTC stored for an exhaust camshaft position sensor, the repair procedure has been revised. Due to the position of the right-hand (Bank 1) sensor, measurement of the gap without removing the front catalyst is extremely difficult as shown in the photo below.

1. Confirm the irregular oscilloscope pattern for the corresponding DTC stored.
2. Remove the sensor from the timing cover and install a .2mm thick shim from the applicable kit.
3. Reinstall the sensor, torque the sensor retaining bolt to 6.4 Nm (4.7 ft. lbs. or 56.4 inch-pounds) then recheck the oscilloscope pattern.

If the pattern is normal, the repair is complete. If the irregular pattern persists, repeat Steps 2 and 3 after removing the .2mm shim and installing a .3 mm thick shim. **ONE SHIM ONLY, NO STACKING.** Repeat as necessary increasing the shim thickness .1 mm at a time until a normal scope pattern can be verified.
