SERVICE BULLETIN

APPLICABILITY: 2013-14MY BRZ

NUMBER: 07-79-13R

SUBJECT: Countermeasures for Frozen Power Windows

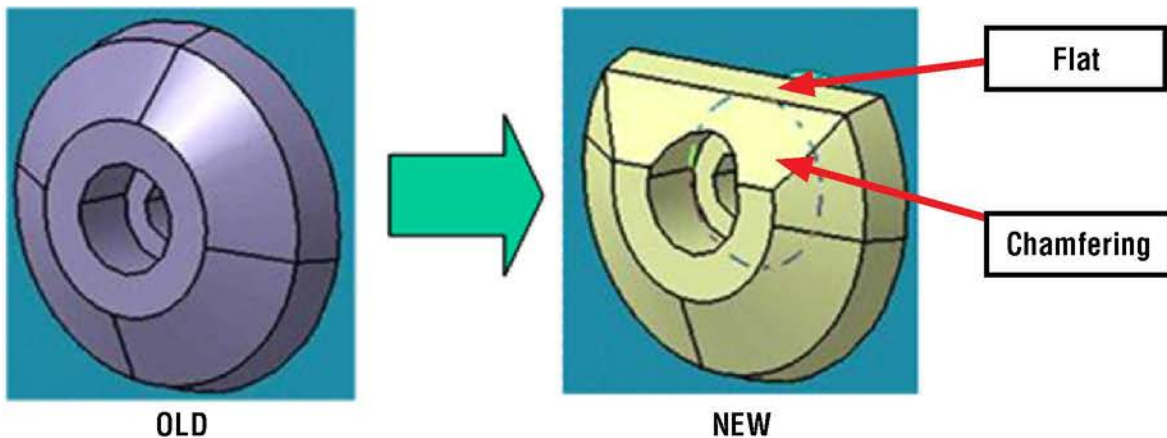
IMPORTANT: The guide door lifters **must** be replaced at the same time the countermeasure power window switches are installed. See the comparison illustration below.
