Service Bulletin

SUBJECT: Special Coverage Adjustment – Negative Battery Cable Loose

MODELS: 2011-2015 Chevrolet Cruze

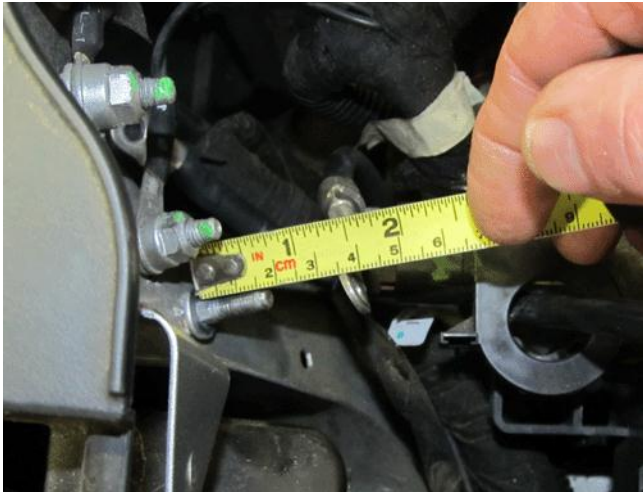
4002404

Note: When installing the body end of the new ground cable, depending on production date, the G100 ground stud could be one of two lengths. The shorter stud length of 17mm is shown in the graphic above.

13. Before installing the negative cable and starter ground cable to the G100 ground stud, measure the length of the stud. The information below will provide direction as to the correct nut to use for attachment
