GROUP ELE	MODEL Multiple Models (See table below)
	NUMBER 077	DATE December 2014
TECHNICAL SERVICE BULLETIN		
SUBJECT: REAR VIEW CAMERA DIAGNOSIS/REPLACEMENT

SUBJECT: REAR VIEW CAMERA DIAGNOSIS/REPLACEMENT

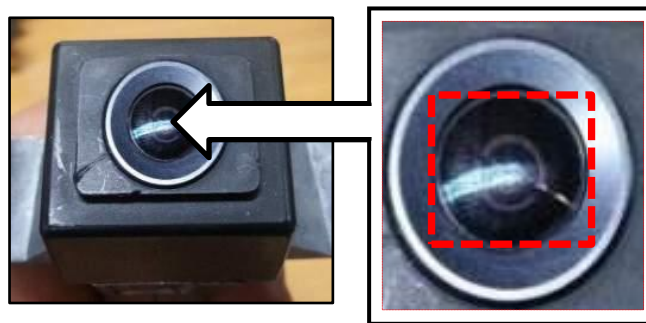
1. Inspect the rear view camera lens for signs of damage due to impact from foreign object. If damage consistent with an impact is found, no further diagnosis is required.

Lens damage due to impact is not considered a warrantable repair.

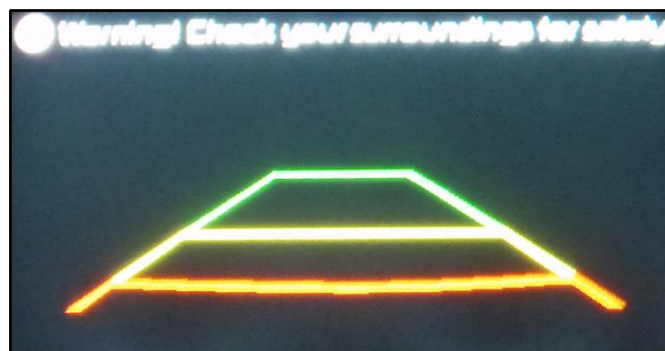
**Intermittent Operation:**

1. For customer complaints related to intermittent operation from the rear view camera, perform the following checks:
 - Confirm the parking guidelines are displayed on the AVN screen. If the guidelines are present and the vehicle owner resides in an area with high humidity, snow or rain, replace the rear view camera with an improved part.

For concerns related to intermittent operation, always try to duplicate the customer concern, prior to replacing the rear view camera.

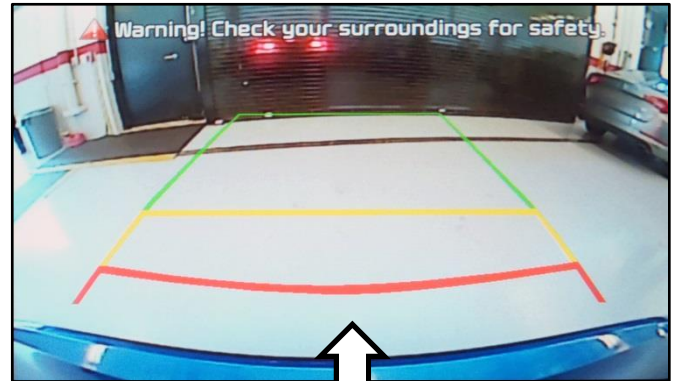
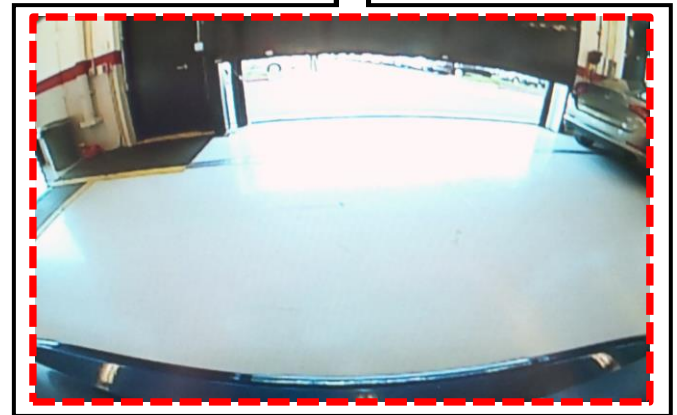
Missing Parking Guide Lines/Black or Blank AVN Screen:

1. If the AVN screen is missing the Parking Guide Lines or displays a black or blank screen, check the AVN system for proper operation:

Missing parking guide lines or a black/blank AVN screen are conditions indicative of an AVN system malfunction, or harness issue related to that system, and not a rear view camera module concern.

2. If the AVN system is functioning properly, perform the following checks:
 - Check the rear view camera wiring harness for pinched or damaged wires.
 - Place the transmission in reverse and confirm the AVN screen switches to rear view mode. If not, check for 12V signal at head unit.
 - If no 12V signal is found at head unit, check the transmission range switch circuit.
