## SERVICE INFORMATION

**APPLICABILITY:** 2011MY Legacy, Outback, Forester, Impreza,  
 WRX, & STI Models

**NUMBER:** 05-58-14

**SUBJECT:** Sound from Rear Suspension Upper Control Arm

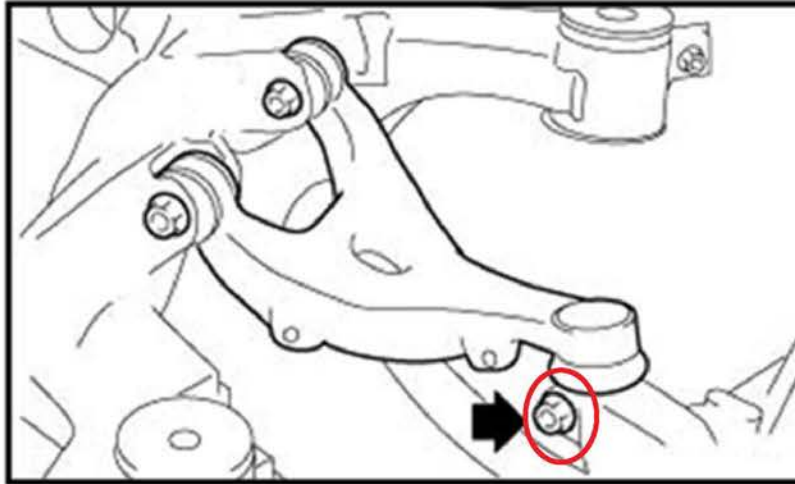
This bulletin provides a procedure for diagnosing and repairing a rattle-type rear suspension sound determined to be coming from the upper control arm ball joint. A revised torque specification for the ball joint retaining nut / bolt set is also included.

1. Once the condition has been confirmed, remove both rear tire and wheel assemblies for access to the suspension components as **BOTH** sides of the vehicle must be inspected.
2. Remove the nut and bolt securing the upper control arm ball joint to the bearing housing as indicated in the illustration above.
3. Rock the upper arm and the bearing housing as necessary to check for any looseness or free-play in the upper arm ball joint.
4. If any looseness in the ball joint is visible or felt, replace the upper arm assembly for that side of the vehicle following the procedure outlined in the applicable Service Manual.
5. **ALWAYS** install a **NEW** ball joint retaining nut and bolt set then torque to 90 Nm (66.4 ft. lbs.).
6. Repeat steps 2 through 5 for inspection / repair to the opposite side of the vehicle.
