MODEL  
2015MY Rio (UB)  
w/1.6L GDI

NUMBER  
145 (REV 1, 12/15/2014)

## TECHNICAL SERVICE BULLETIN

SUBJECT: SERVICE ACTION: ECM UPGRADE – MIL ON WITHOUT  
DTC CODE (SA 175)

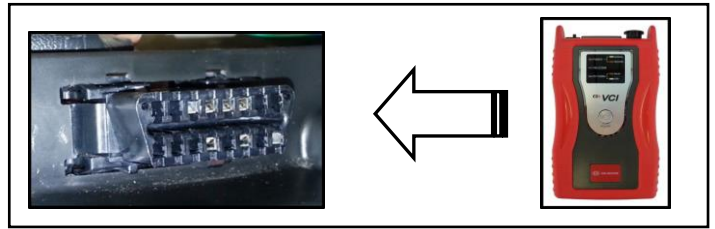
4. Connect the Main 16-pin DLC cable (GHDM – 241000) to the OBD-II connector, located under the driver's side of the instrument panel.

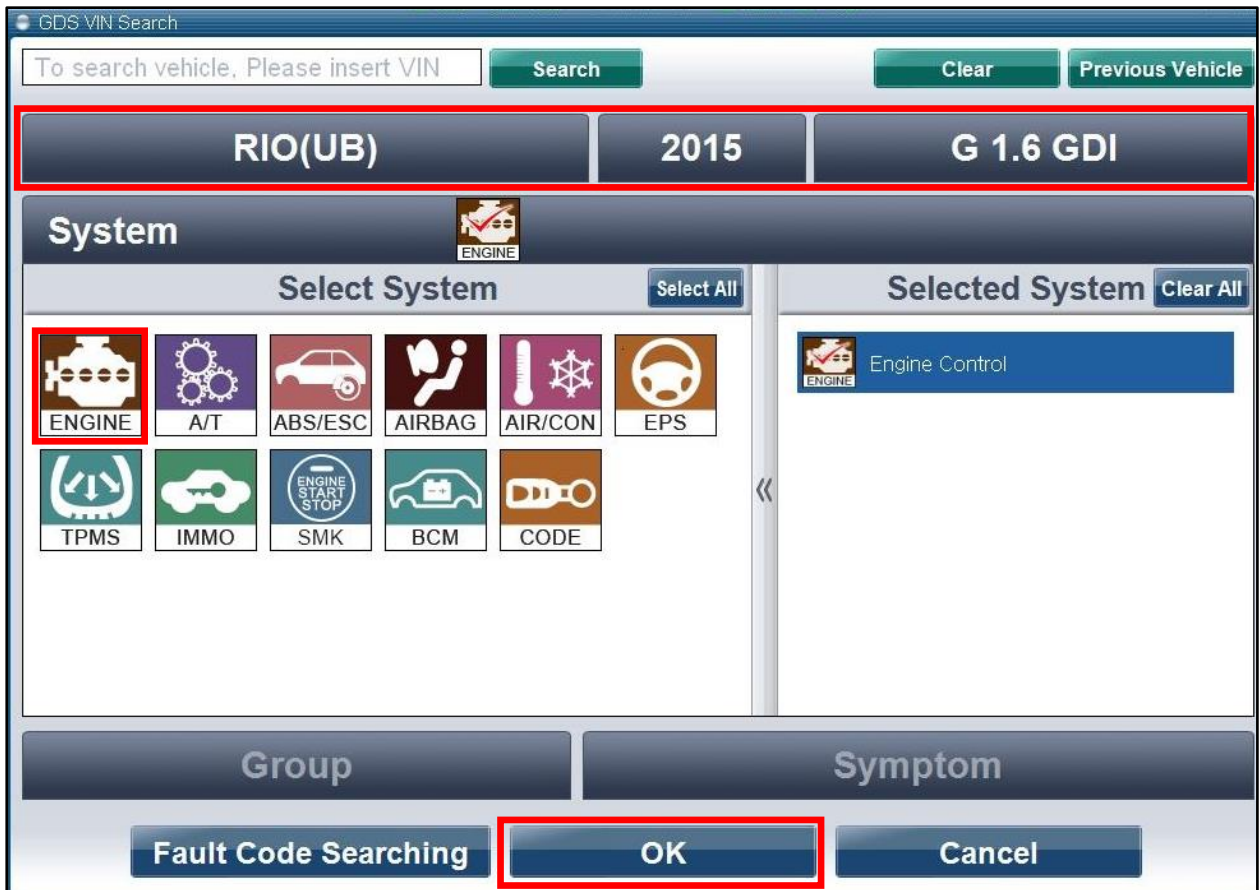
5. With the ignition key ON, turn ON the VCI and GDS. Access the GDS vehicle identification number (VIN) screen and configure the vehicle using the **VIN AUTO DETECT** Function.
6. Select **ENGINE** system and click **OK**.

7. Select **ECU Upgrade** from the bottom right-hand corner. Next select **Auto Mode**, and then **Engine**. Perform the ECM upgrade in accordance with normal GDS ECM upgrade procedures.
