SUBJECT: Service Update for Inventory and Customer Vehicles
220 Amp Generator Fuse Block Corrosion
Expires with Base Warranty

MODELS: 2015 Chevrolet Silverado 2500 HD
2015 GMC Sierra 2500 HD
Equipped with 220 Amp Generator RPO KW5

Subject: 14154 – Service Update Bulletin
220 amp Generator Fuse Block Corrosion

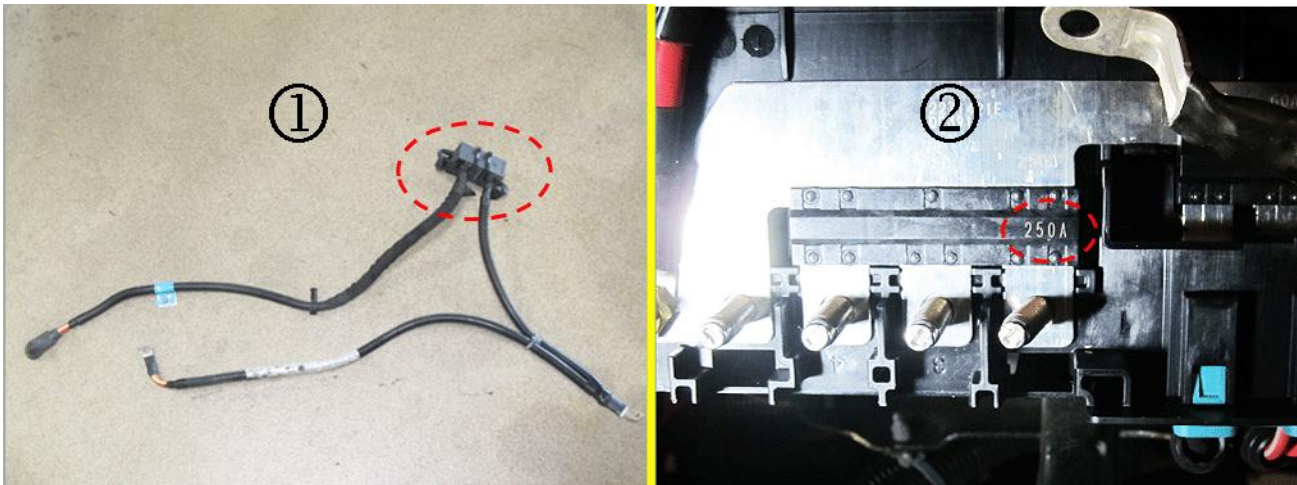
40094453

This bulletin provides a service procedure to relocate the separate 250 Amp fuse into the pre-fuse assembly on top of the vehicle battery on **certain** 2015 model year Chevrolet Silverado 2500 HD and GMC Sierra 2500 HD vehicles equipped with a 220 Amp Generator (RPO KW5). These vehicles may, due to corrosion at the ends of the fuse, experience a resistance build-up that does not allow current to flow through the fuse, resulting in the generator not being able to charge the vehicle battery. The battery symbol may appear on the IP and a message in the driver information center will show "Service Battery Charging System." As the battery loses charge, the vehicle may stall or not be able to start when the battery goes below 11.3 Volts. Depending on the state of charge of the battery when this occurs, the vehicle may have between 50-85 minutes before any potential stall condition.

Note: With the new parts design, the 250 Amp fuse which was previously located on the cables (1) has now been re-located in the fuse battery distribution block (2).
