Program Bulletin

CUSTOMER SATISFACTION PROGRAM

SUBJECT: Upfitter Auxiliary Switches

MODELS: 2014 Chevrolet Silverado 1500
2015 Chevrolet Silverado
2014 GMC Sierra 1500
2015 GMC Sierra
Equipped with Auxiliary Switch Bank (RPO 9L7)

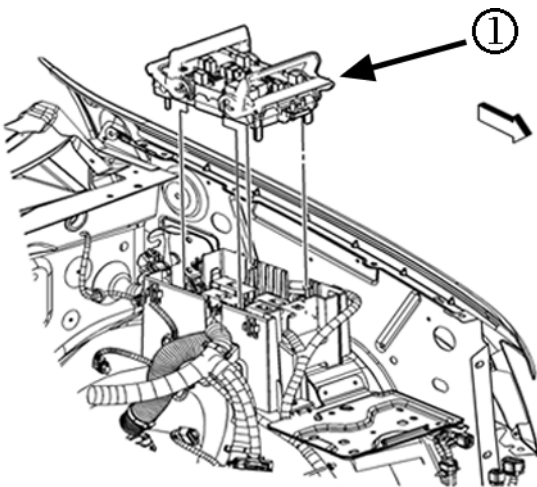
3963531

Certain 2014 and 2015 model year Chevrolet Silverado and GMC Sierra vehicles equipped with the Auxiliary Switch Bank (RPO 9L7) may have an electrical issue created when one or both Upfitter fuses used for the instrument panel mounted auxiliary switch bank are moved from the battery feed to the ignition feed position. If the fuse positions are altered, the engine could continue to run after the ignition switch is turned off. There could also be an inadvertent glowing of the auxiliary switch indicators, additional parasitic current drain, or a no start condition.

1. Remove the underhood electrical center (1). Refer to *Underhood Electrical Center or Junction Block Replacement* in SI.
2. Install the new underhood electrical center. Refer to *Underhood Electrical Center or Junction Block Replacement* in SI.
