SUBJECT: Service Update for Inventory and Customer Vehicles
Rear Door Inside Handle Release Cable Misrouted
Expires with Base Warranty

MODELS: 2014-2015 Cadillac CTS Sedan (VIN A)

Subject: 14576 – Service Update Bulletin
Rear Door Inside Handle Release Cable Misrouted

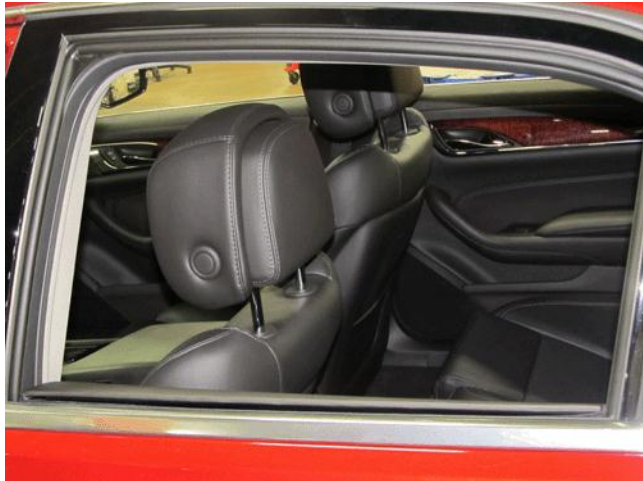
3997956

Fully open both left and right rear windows and inspect for full travel of the door glass down into the door.

- If the windows lower fully into both doors, no further action is necessary.

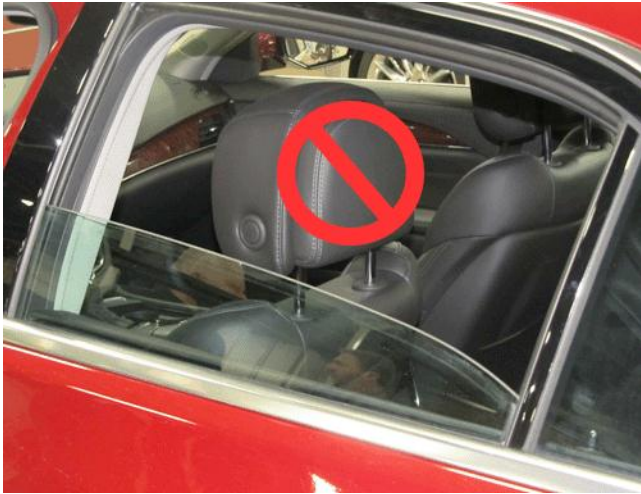
3997957

- If window travel is restricted on either rear side door, continue ahead to the *Repair Procedure*.

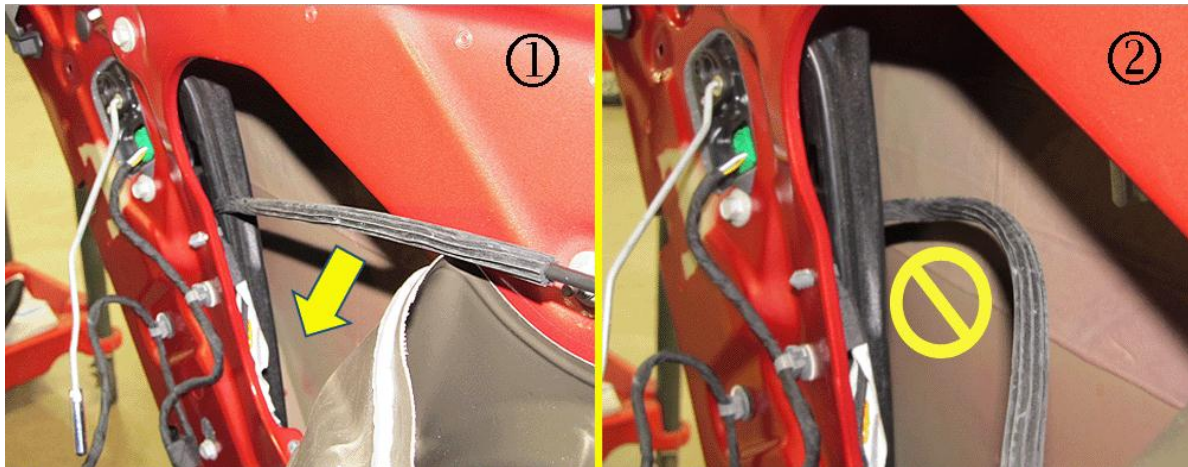
3997967

Note: When installing the new rear side door inside handle cable, ensure proper routing of the cable within the door. As shown in the graphic above, the cable **MUST** be routed on the inboard side (1) of the vertical glass channel, **NOT** the outboard side (2).
