# SERVICE BULLETIN

## APPLICABILITY: 2013 BRZ

NUMBER: 12-168-14 DATE: 03/31/14

SUBJECT: Appearance Imperfection of Inside Rear View Mirror

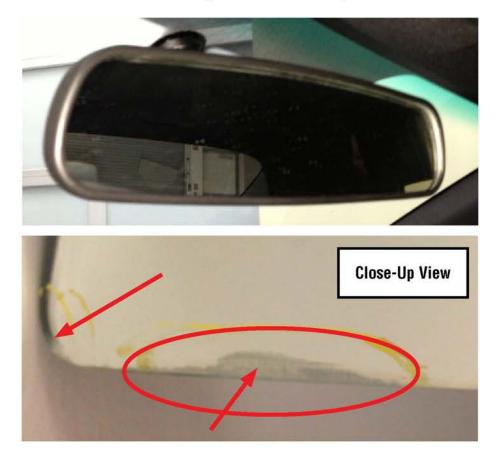
This bulletin informs of how to repair a possible visual imperfection in the frameless rear-view mirror. A countermeasure mirror assembly is now available to address a customer concern of what appears to be de-lamination of the mirror glass as shown in the photo below.

The part number for the countermeasure rear-view mirror assembly is 92039CA000.

Once the delamination of the mirror glass has been verified, replace the assembly with the countermeasure part following the procedure outlined in the applicable Service Manual.
