Recall Bulletin

PRODUCT EMISSION RECALL

SUBJECT: Oxygen Sensor Fracture

MODELS: 2011-2013 Chevrolet Express
2011-2013 GMC Savana
Cutaway Equipped with Gasoline or Liquefied Petroleum Gas (LPG) Fuel Engines

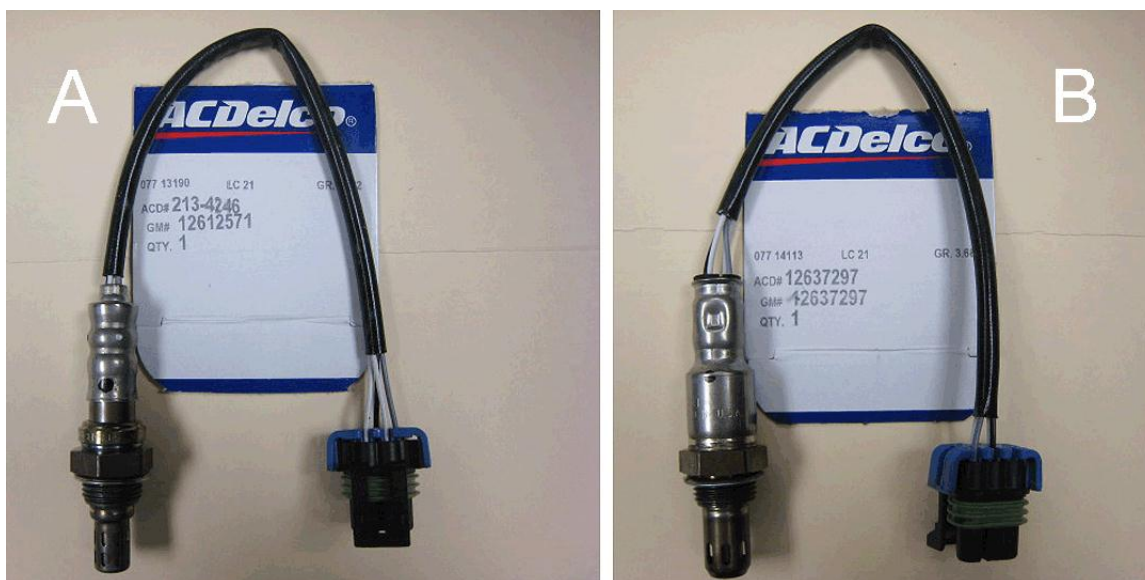
3961549

(A) 2011 through early 2013 OE production first design male connector. Replace the part with a second design part with a male connector, P/N 12637297. (B) 2011 through 2013 second design service part, P/N12637297. Do NOT replace this part unless the part has failed. If the part has failed, replace the part with the second design part with a male connector, P/N 12637297.

3. Determine if a first design (A) or second design (B) heated oxygen sensor is installed using a light and mirror.
 - If a second design (B), P/N 12637297, P/N 12656071 heated oxygen sensor is currently installed, no further action is required. Lower the vehicle. Refer to *Lifting and Jacking the Vehicle* in SI.
 - If a first design (A), P/N 12612571, heated oxygen sensor is in place, remove the sensor and replace it with a second design heated oxygen sensor. Refer to *Heated Oxygen Sensor Replacement –Bank 2 Sensor 2* in SI and *Heated Oxygen Sensor Replacement –Bank 1 Sensor 2* in SI.
4. After installing the new heated oxygen sensors, reprogram the ECM. Refer to *Engine Control Module Programming* in this bulletin.

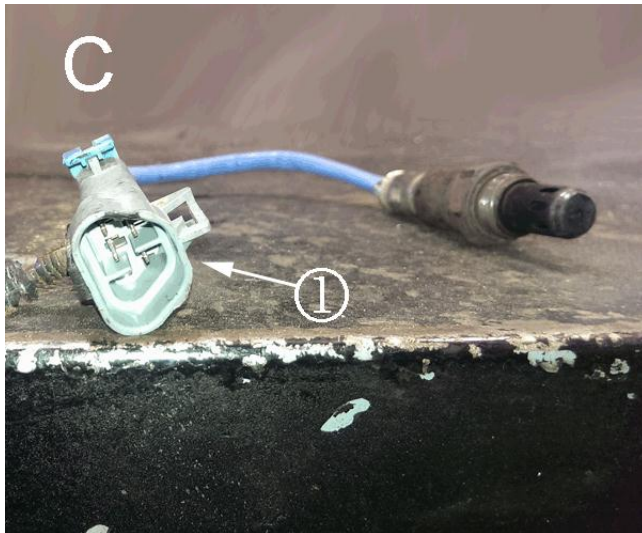
3961552

(C) This is the second design 2013 production sensor with the female plug (1). The sensor and plug change was made to indicate the new design. Do NOT replace this sensor, P/N12656071, unless the part has failed.
