Service Bulletin

SUBJECT: Special Coverage Adjustment – Electric Power Steering Assist

**MODELS: 2006-2009 Chevrolet HHR (non-turbo)
2003 Saturn ION
Equipped with Electric Power Steering**

Subject: 14119 – Special Coverage Adjustment
Electric Power Steering Assist

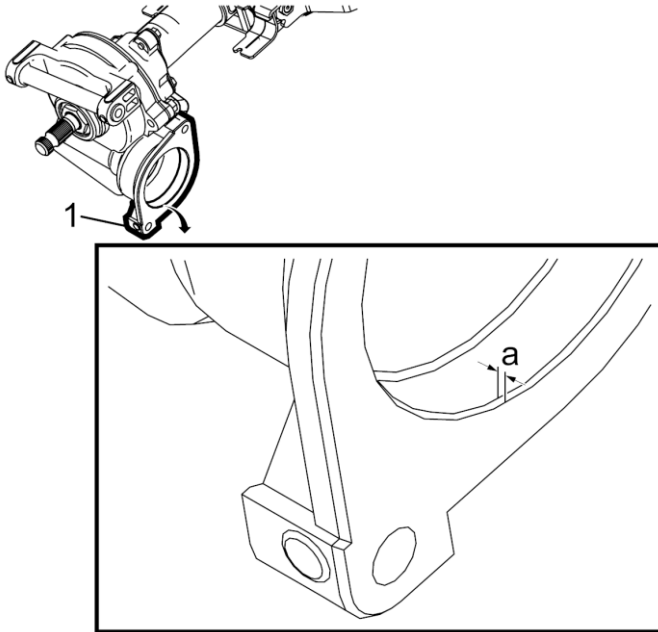
SERVICE PROCEDURE**Power Steering Assist Motor Housing Inspection -- All Vehicles Except Chevrolet HHR**

Caution: Do not install a seal on a "first design" steering motor. Installing a seal on a "first design" steering motor may damage the steering motor which may result in loss of assist steering. A seal is only required on a "second design" steering motor – the motor with the larger chamfer.

Before installing the power steering assist motor, inspect the power steering assist motor housing (1) to verify the steering column design:

- *First Design:* If the chamfer (a) is **1 mm (0.04 in)** and **30 degrees** then the steering column is the first design and a power steering assist motor O-ring seal is **NOT** needed.
- *Second Design:* If the chamfer (a) is **2.7 mm (0.11 in)** and **45 degrees** then the steering column is the second design and a **NEW** power steering assist motor O-ring seal **IS** needed.

1. Remove the power steering assist motor. Refer to *Power Steering Assist Motor Replacement* in SI.
2. Install the new power steering assist motor. Refer to *Power Steering Assist Motor Replacement* in SI.
